## Tube Failure of Vertical Heat Exchanger

Ali Sami Al-Hassan  
Sr. Inspection Engineer  
Sipchem

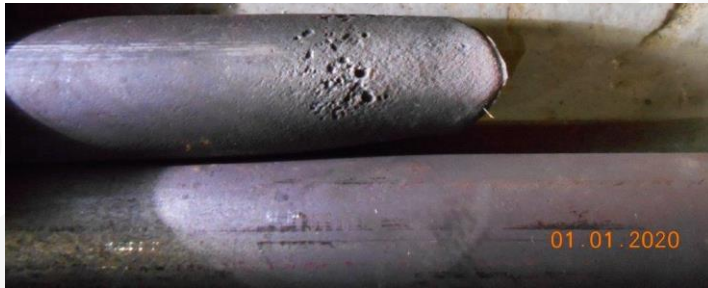
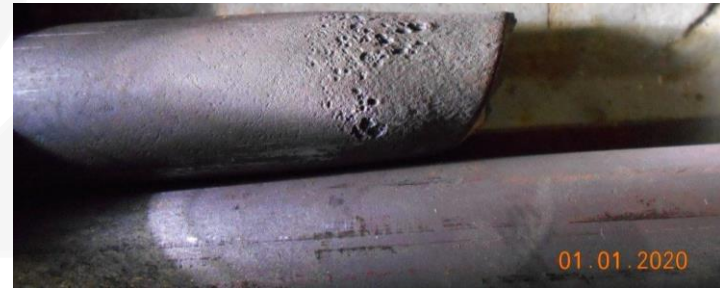
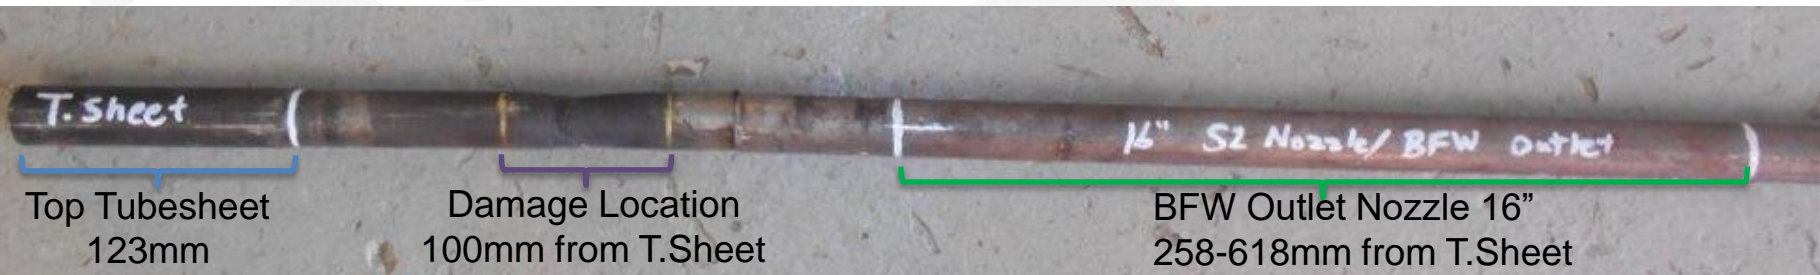
- For the purpose of analysis, 2 tubes were pulled and sent for failure analysis
- **Tubes Condition:**
  - Tubes were sheared during pulling indicating a weak area and found the tube near the sheared location to have external damage (deep grooves).
  - The damage is located around 100mm from the top tube sheet.
  - No apparent damage observed on the plane of BFW inlet

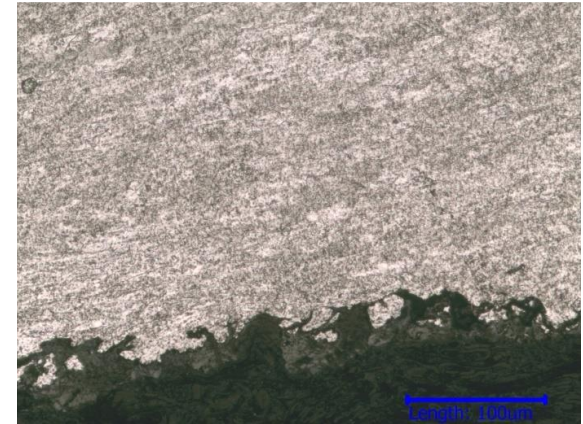
- **Visual Examination:**
  - Tubes were sheared due to tensile overload caused by localized external damage
  - External pitting around sheared area
  - No internal degradation observed
- **Metallographic examination (SEM):**
  - External pitting caused by corrosion
  - The examination shows abnormal condition of the microstructure attributed to possible improper or lack of heat treatment (normalizing & tempering),
    - Expected: ferrite and bainite
    - Observed: ferrite with fine, spheroidized carbides
- **Chemical analysis, EDX and Hardness:**
  - No Significant findings

Pitting Damage

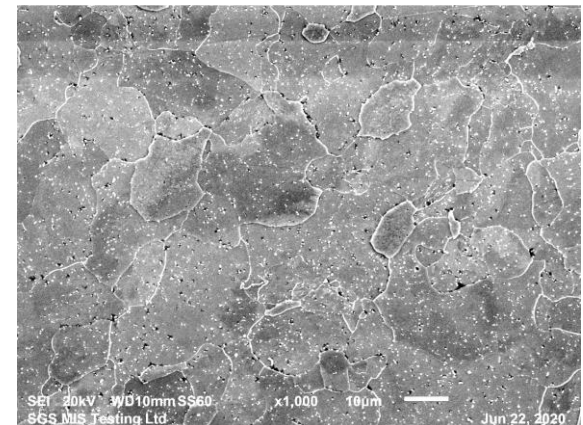
Microstructure

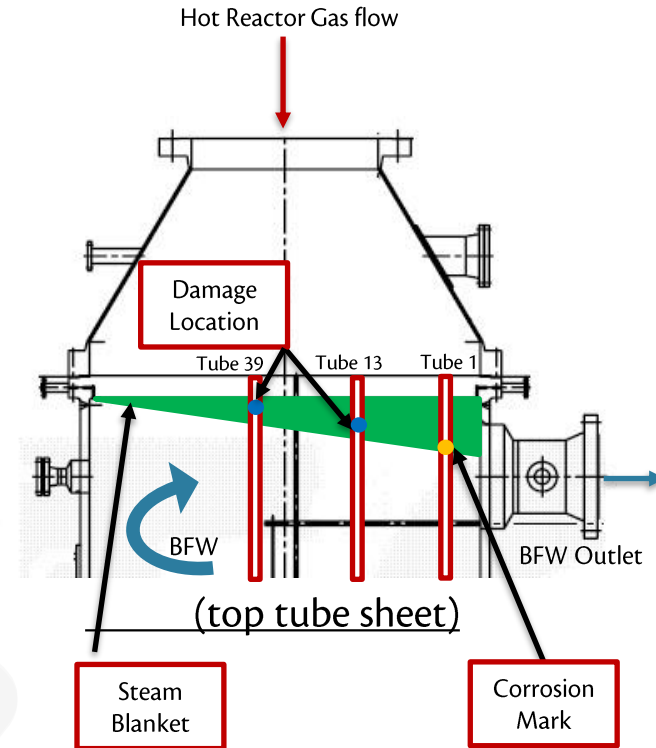
- The manifestation of the steam blanket is an inherent design issue that will persist as long as the exchanger orientation is vertical
- The location of the BFW outlet nozzle makes it impossible for the BFW level to be full up to the top tube sheet
- All corrosion (pitting) occurred on the tubes external surface at the interface between the steam and the BFW.
- The damage is localized and more severe at BFW outlet

- Strict control of Boiler Feed Water (BFW) Chemistry, it shall be maintained always within the specifications.
- Explore the possibility to install ceramic sleeves at the top tubesheet reduce the heat below the tubesheet and minimize the steam blanket
- Explore the possibility to replace the exchanger with horizontal design to eliminate the presence of the steam blanket

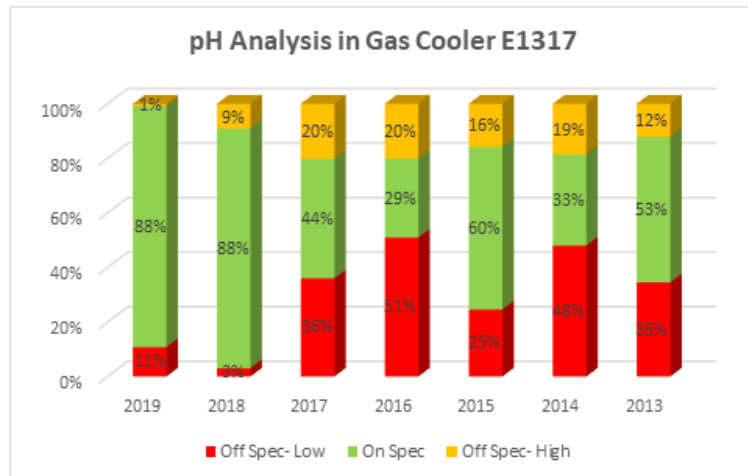
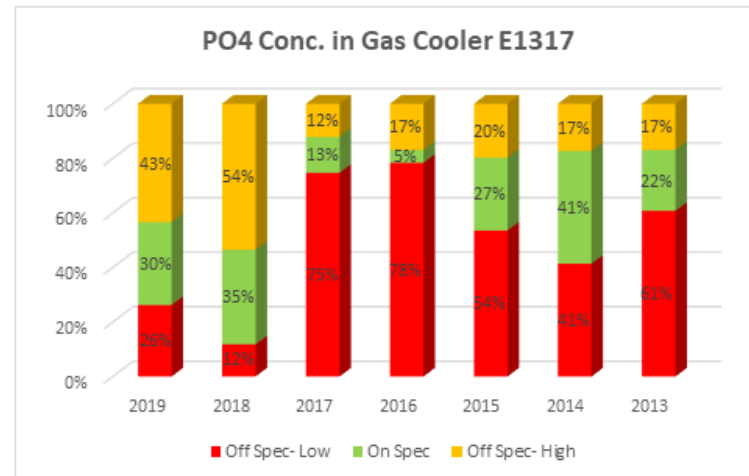
- Off-spec of Phosphate and pH was observed for extended time
- Having low values of pH will remove the protective layer (Magnetite) and make the surface vulnerable for general or localized corrosion.
- Having high level of chemicals will form deposits at the interface between steam and BFW over the tube surface and start under deposit corrosion.
