FAILURE ANALYSIS OF WASTE HEAT BOILER TUBES

Abdulmohsen Al-Sahli, Avtandil Khalil Bairamov, Abdulaziz Al-Meshari, Gys Van Zyl, and Ali Al-Shawaf

April 26, 2017

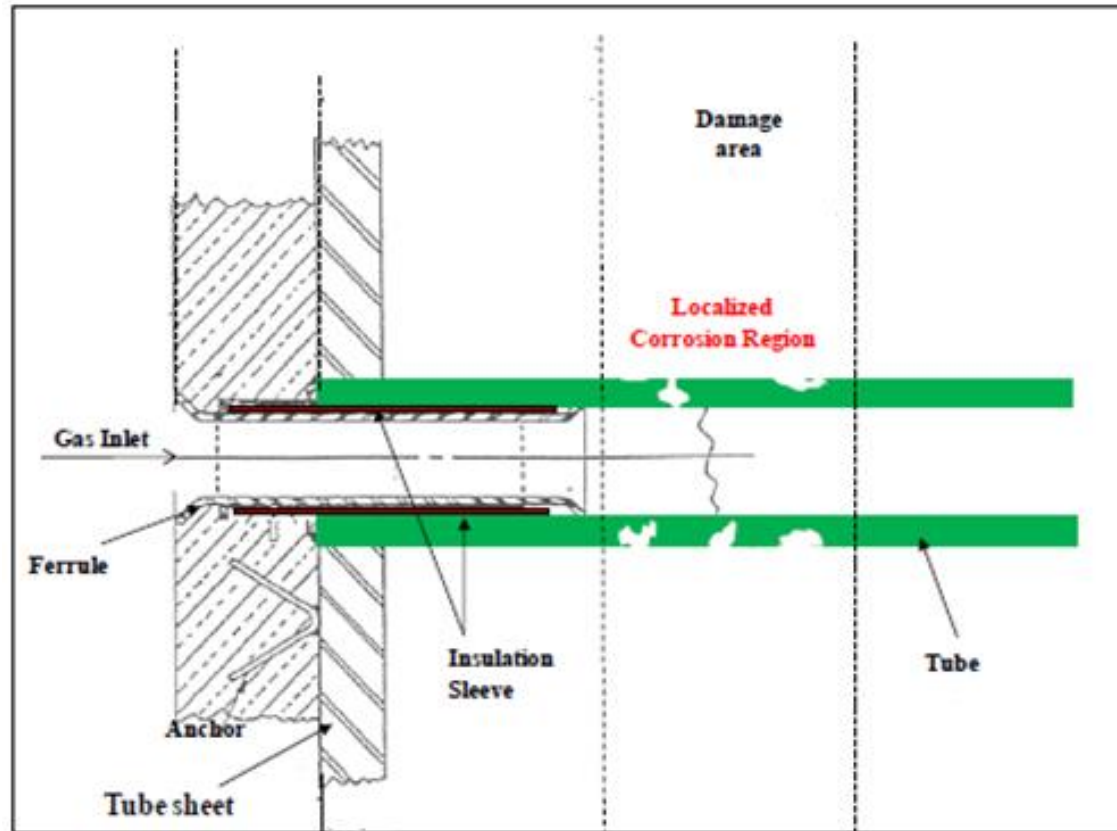
SCHEMATIC DIAGRAM OF DAMAGE LOCATIONS

The damage has been observed to be confined to areas after the ferrule's end.

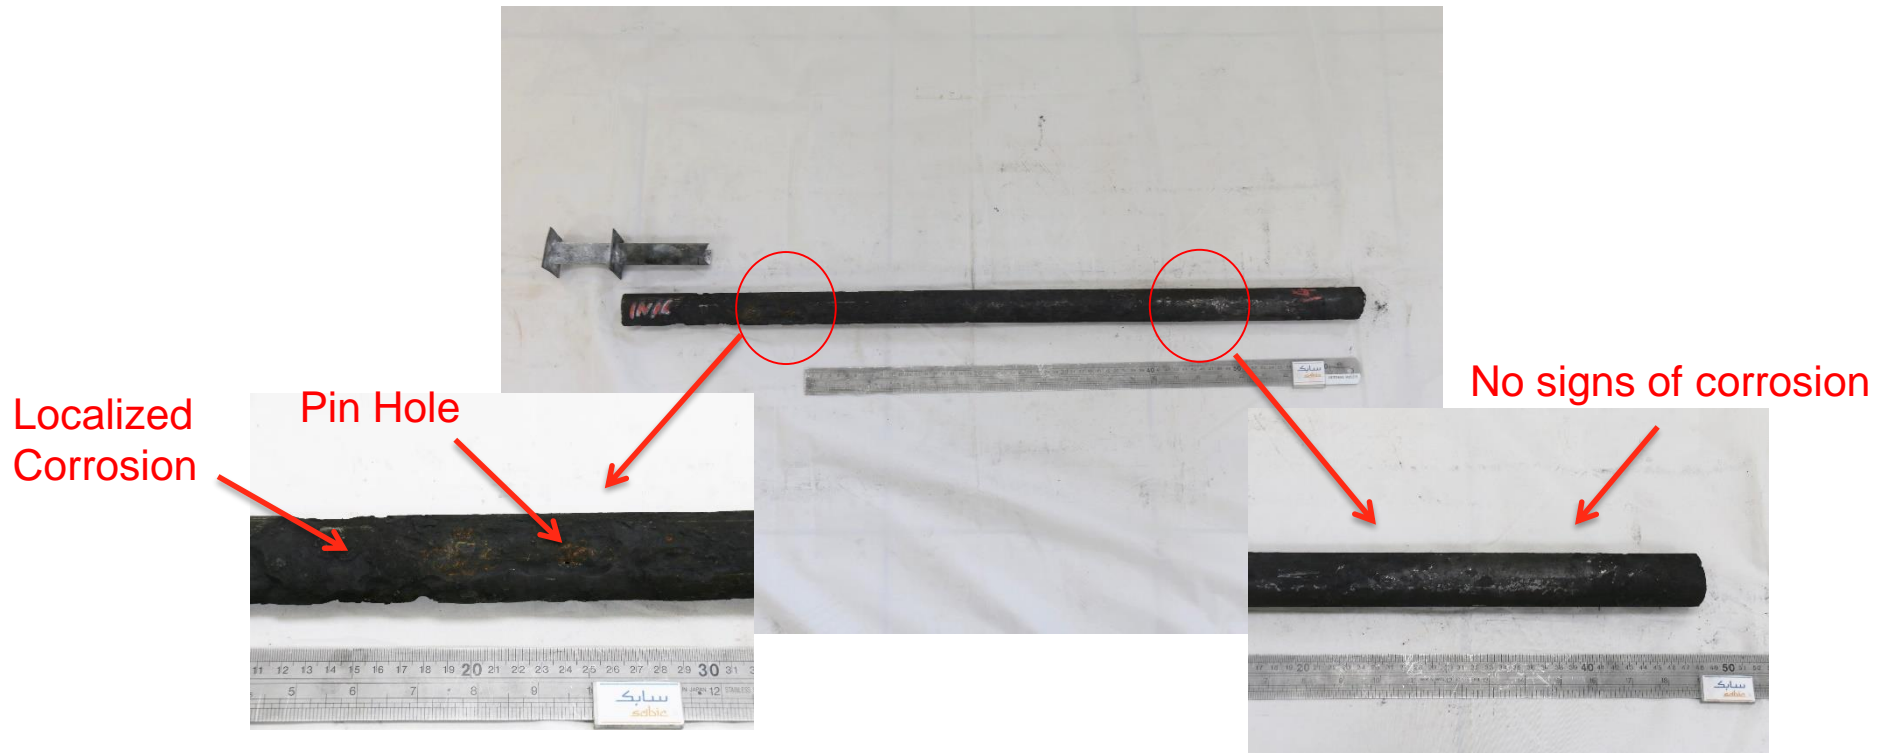
VISUAL EXAMINATION OF THE LEAKED TUBE

The leaked tube sample in as-received condition.

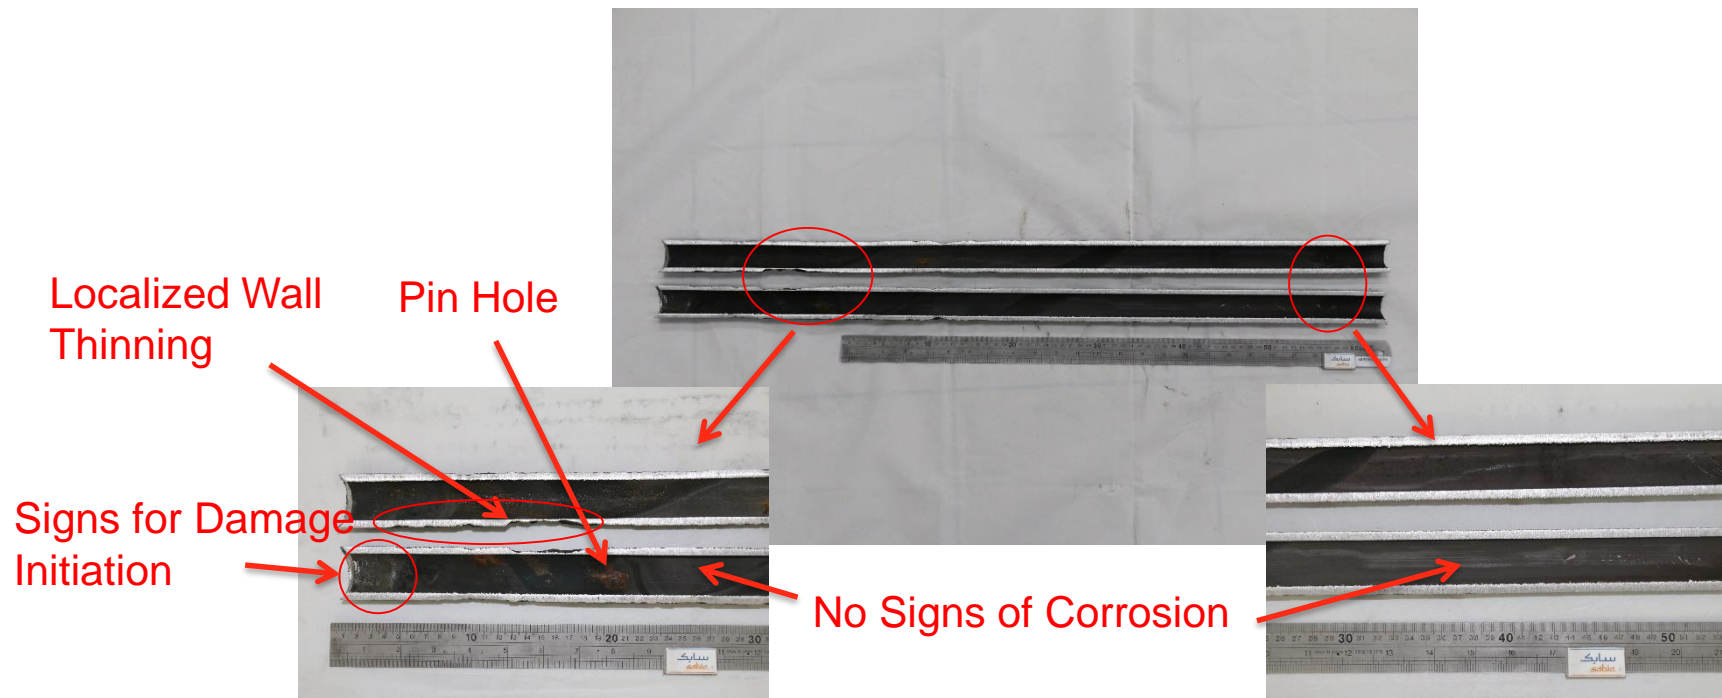
THE INTERNAL SURFACE OF THE LEAKED TUBE

The internal surfaces of the leaked tube.

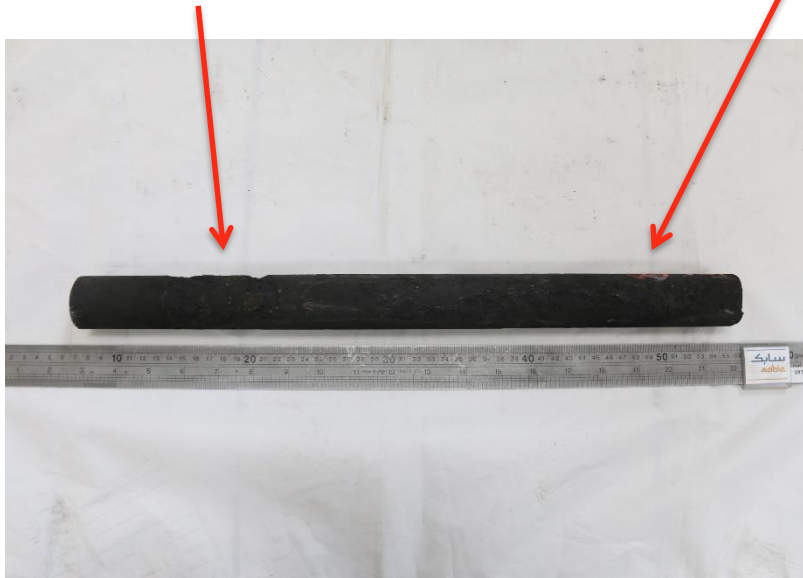
Localized Corrosion

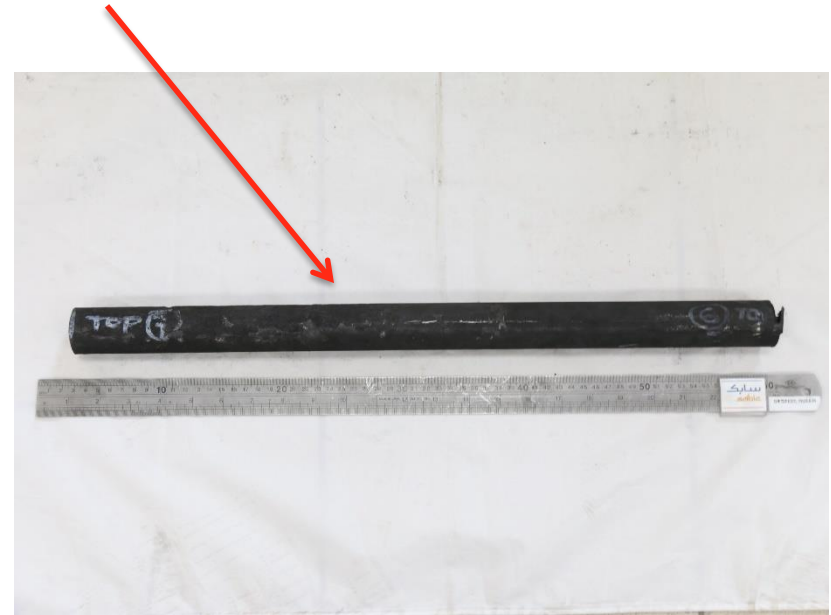
No signs of corrosion

The severely tube sample in as-received condition.

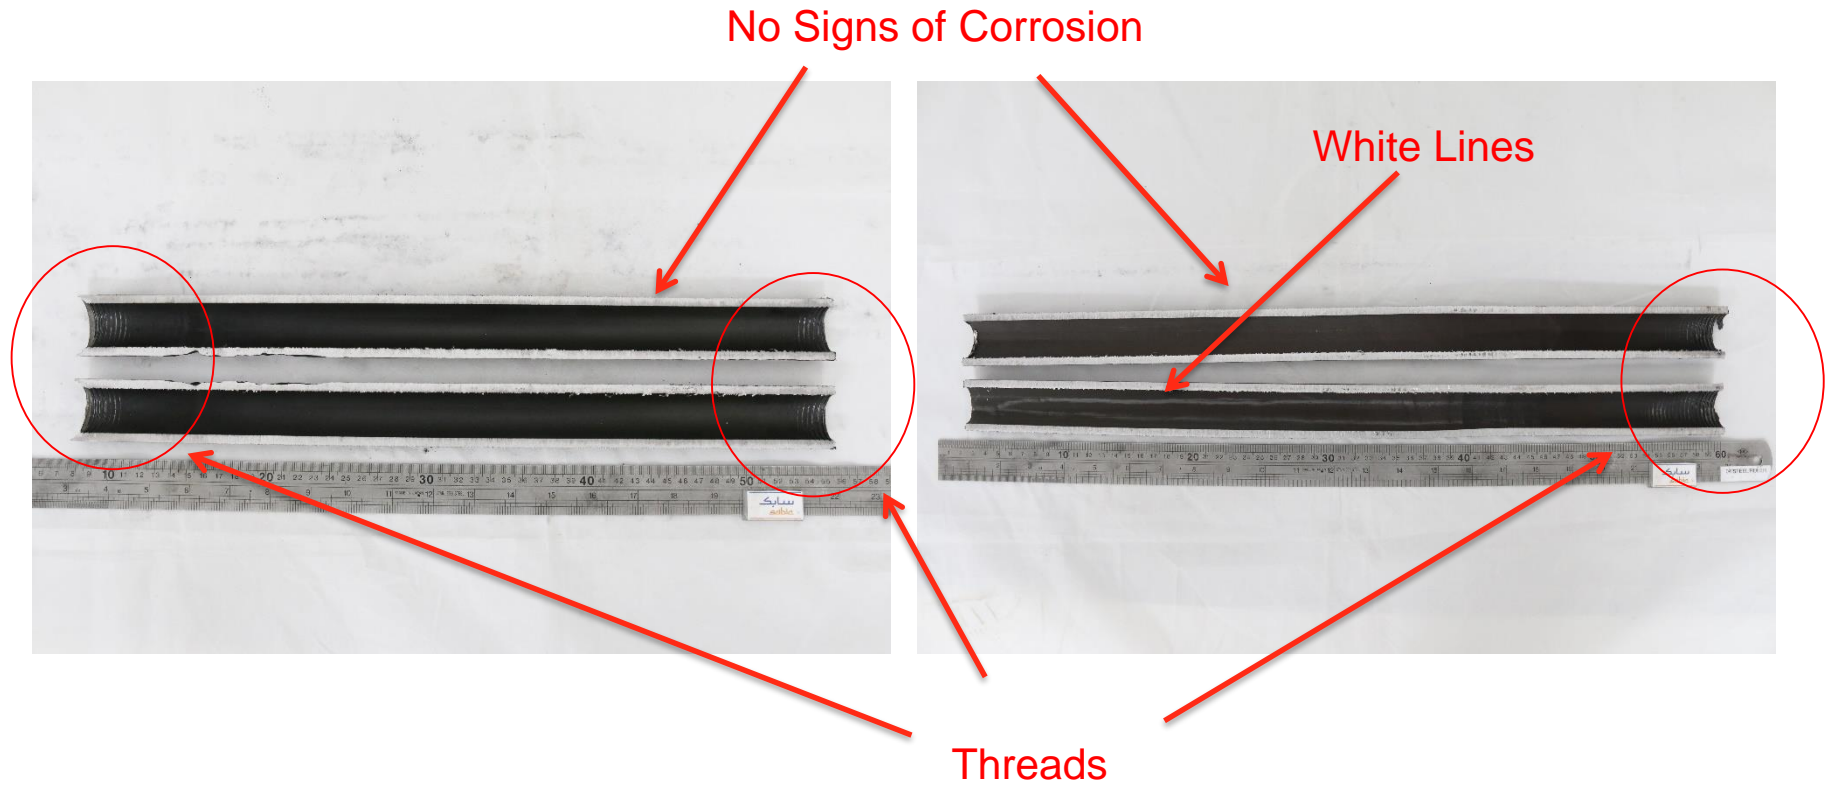
INTERNAL SURFACE OF THE THINNED TUBE

The internal surfaces of the thinned tube.

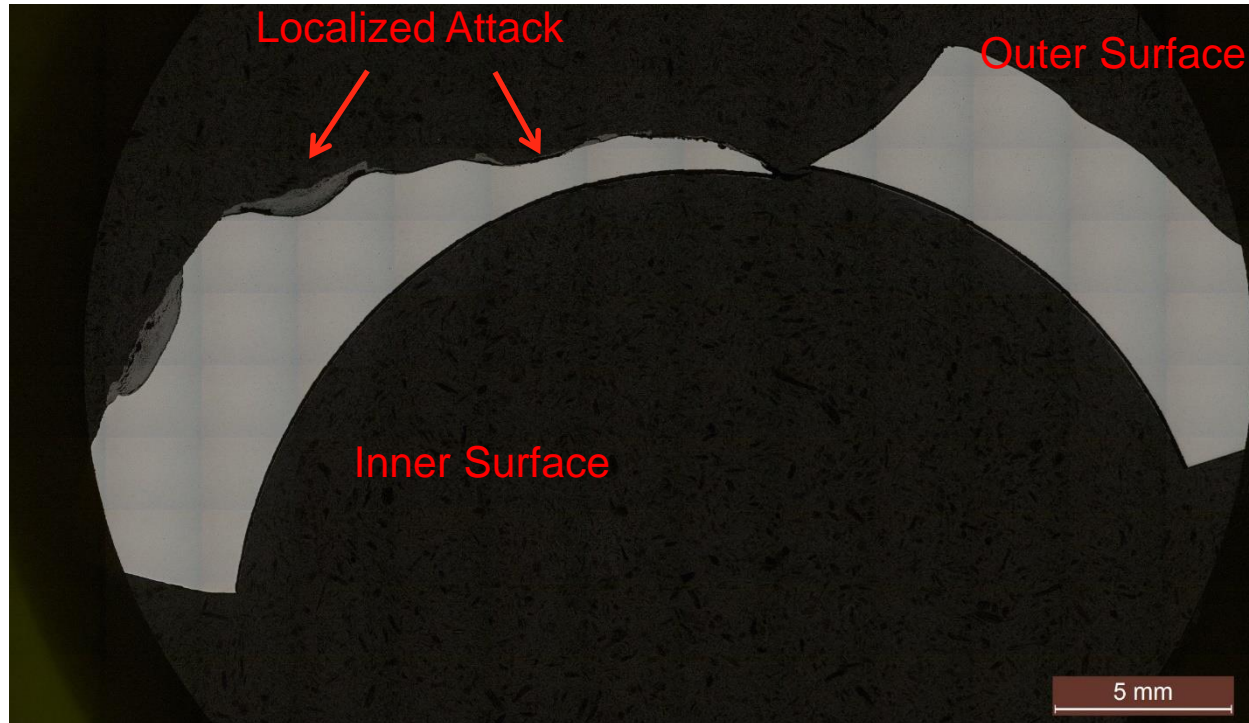
CROSS SECTION OF THE LEAKED TUBE

Micrographs showing severe localized corrosion from the outer surface.

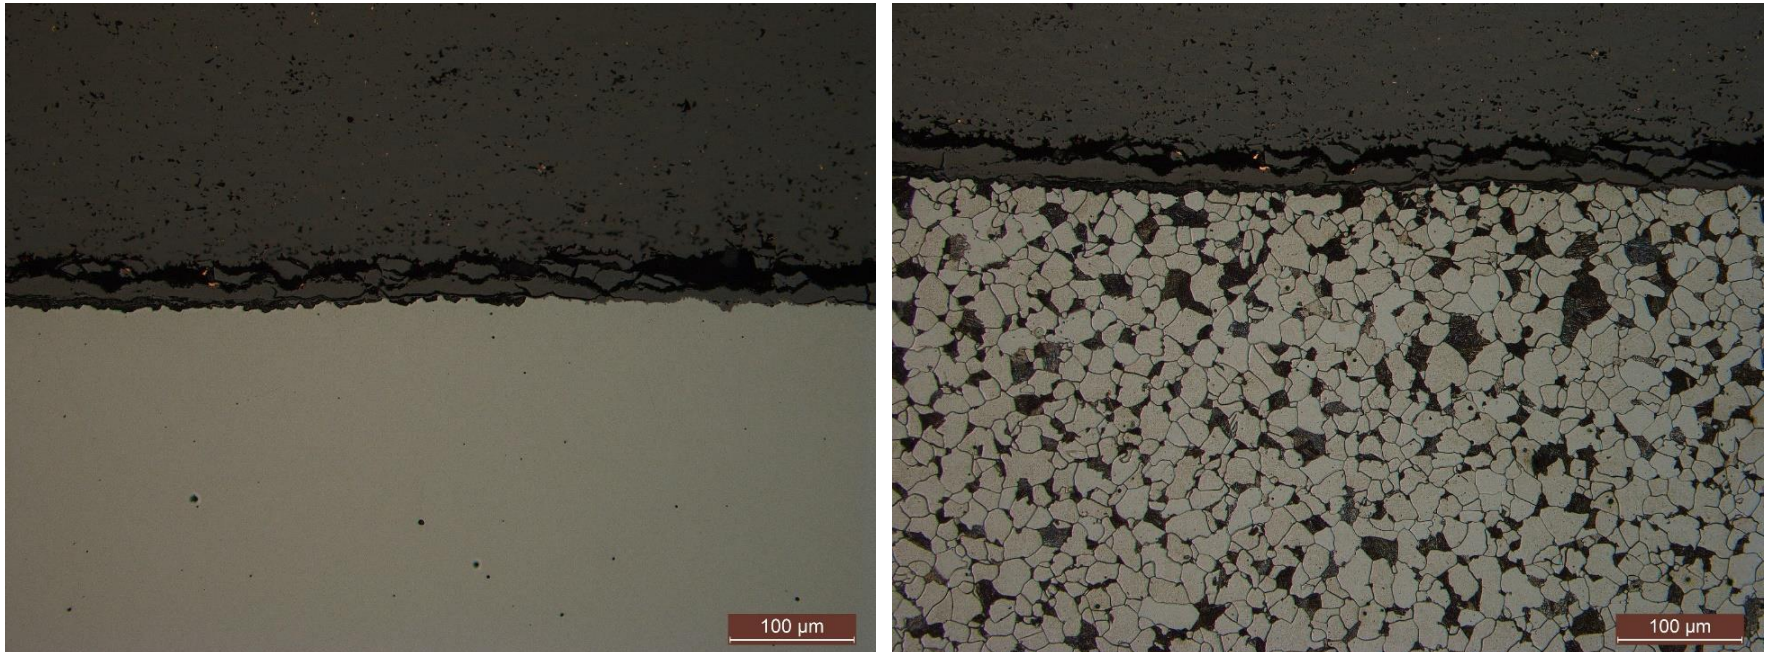
MICROSTRUCTURAL ANALYSIS OF TUBES

Micrographs of the leaked tube, as polished (left) and etched with 2% Nital (right).

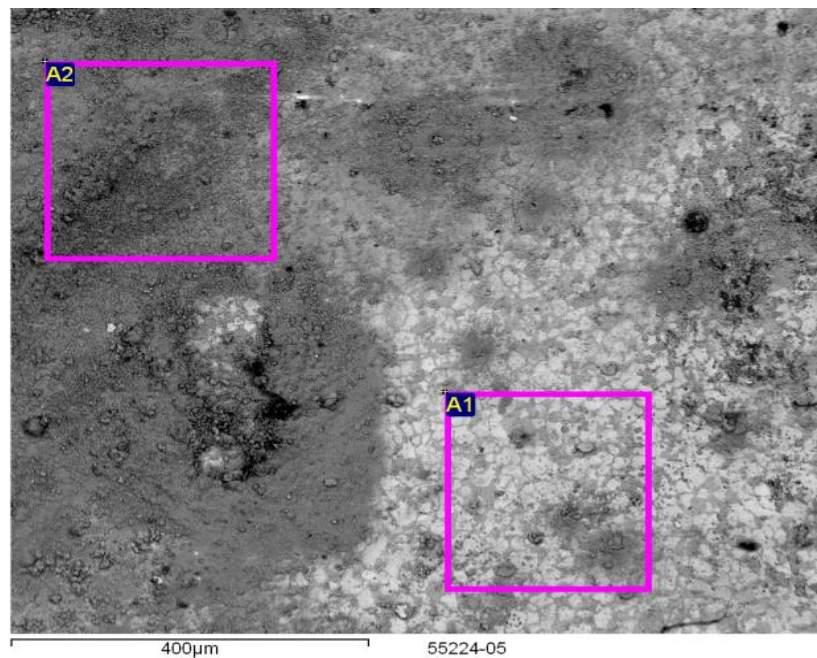
SEM/EDS OF TUBE EXTERNAL SURFACE NEAR PINHOLE

| Spectrum | C | O | Na | Si | S | Fe | Cu |
| A1 | 2.51 | 22.79 | | 0.22 | 0.20 | 73.53 | 0.75 |
| A2 | 2.59 | 34.73 | 0.18 | 0.33 | | 62.17 | |

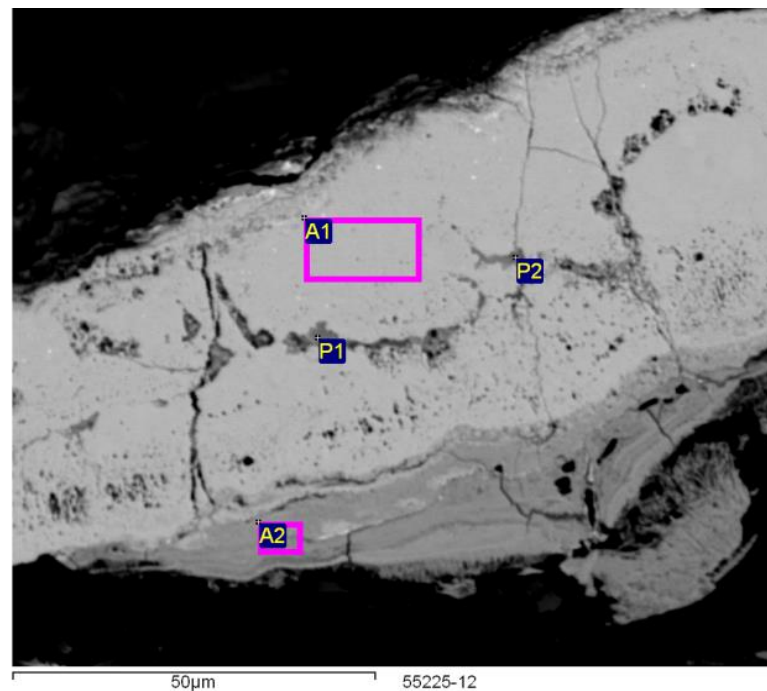
SEM/EDS OF TUBE INTERNAL SURFACE AT PINHOLE

| Spectrum | C | O | Na | Al | Si | P | Ca | Mn | Fe | Mo |
| A1 | 1.17 | 32.02 | 0.46 | | 0.38 | | | | 65.13 | 0.83 |
| P1 | 2.45 | 33.54 | 0.66 | 0.15 | 0.90 | 5.87 | 0.31 | 7.30 | 48.82 | |
| P2 | 2.13 | 33.27 | 1.02 | 0.35 | 0.31 | | | | 61.54 | 1.38 |
| A2 | 2.55 | 35.51 | 0.18 | 0.28 | 0.12 | | | | 61.37 | |

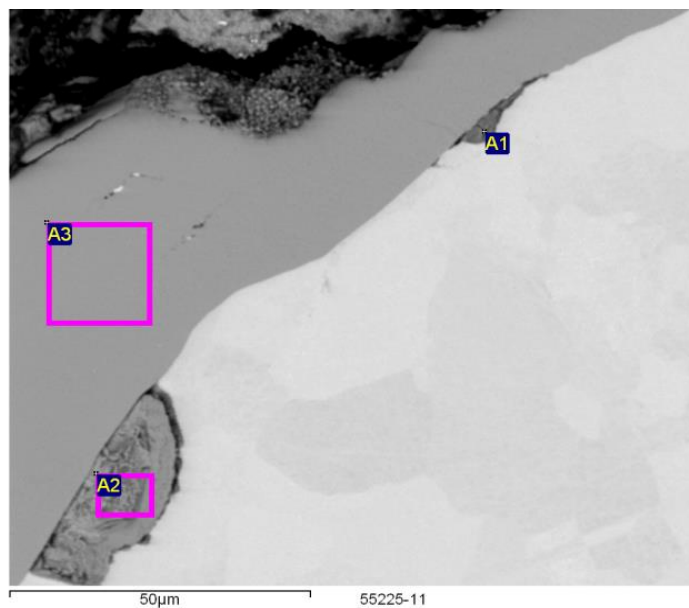
SEM/EDS OF TUBE EXTERNAL SURFACE AT PINHOLE

| Spectrum | C | O | Si | S | Cl | Fe | Cu | Mo |
| A1 | 1.76 | 35.54 | 0.65 | | 0.42 | 60.99 | 0.64 | |
| A2 | 3.86 | 32.57 | 0.64 | 0.68 | | 62.26 | | |
| A3 | 1.30 | 31.87 | 0.31 | | | 65.72 | | 0.80 |

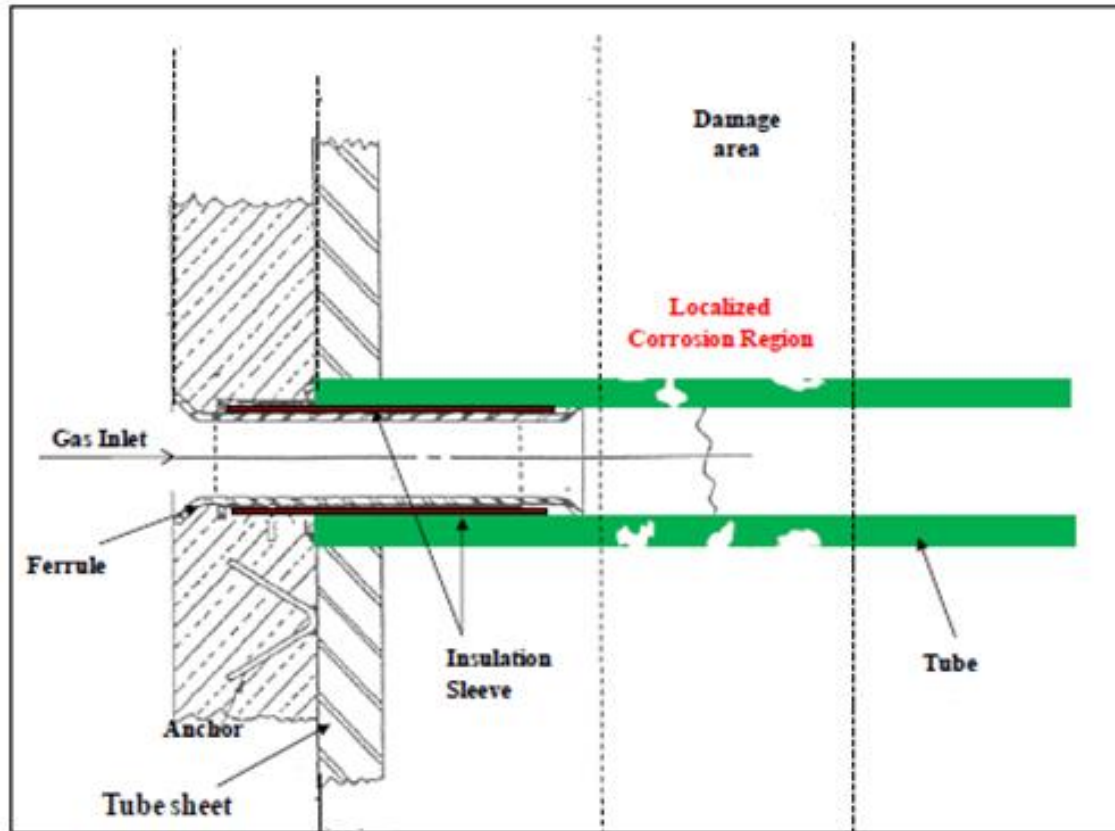
FAILURE MECHANISM

The experimental observations suggest that the tubes failed by caustic gauging.

- The experimental observations suggest that the tubes failed by caustic gauging.
- The damage is confined to a small portion of the tubes where deposit formation has been observed.
- Deposition resulted mostly due to the quality of BFW.
- Reduction of temperature gradient at the entrance of the boiler could help in reducing deposition.
