UNEXPECTED SILENT KILLER IN HIGH-GRADE MATERIAL

RAYAN SALWATI
PETROMEMYA , SABIC
SAUDI ARABIA

INTRODUCTION

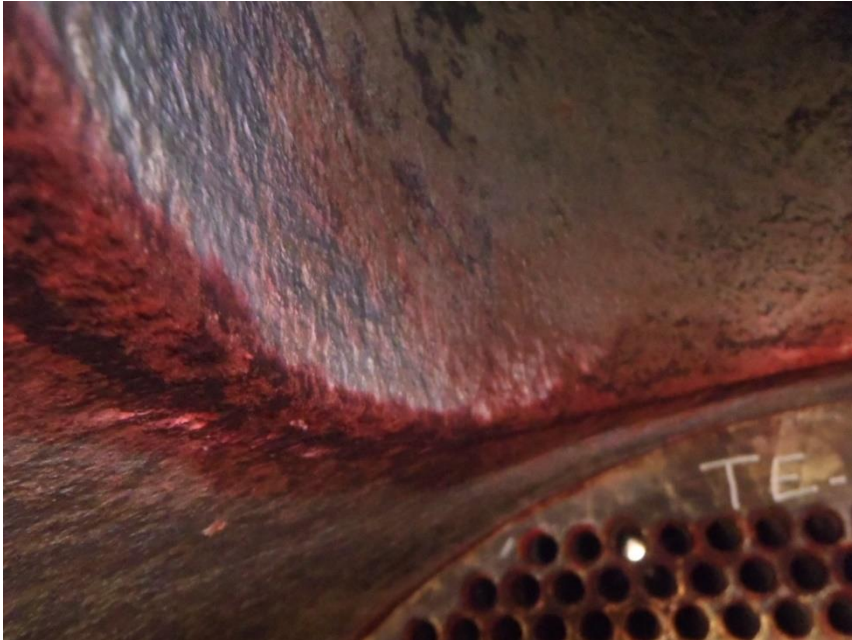
Inlet shell found heavily corroded

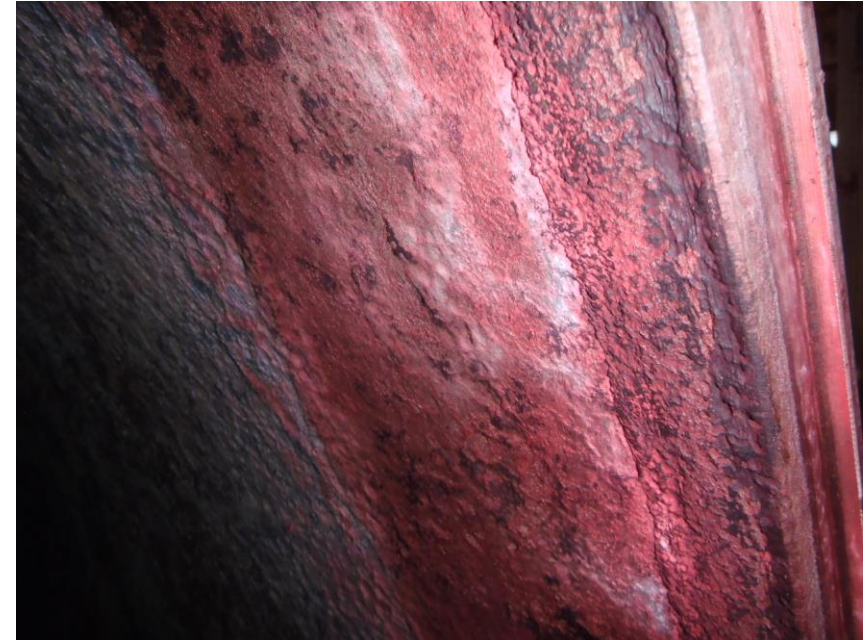
Inlet shell found heavily corroded

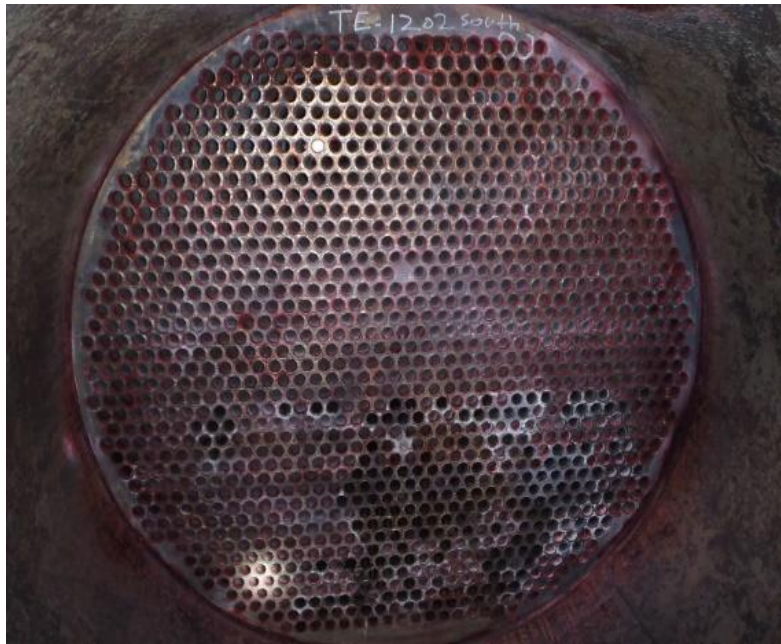
Severe Corrosion at tube
Inlet side tube sheet

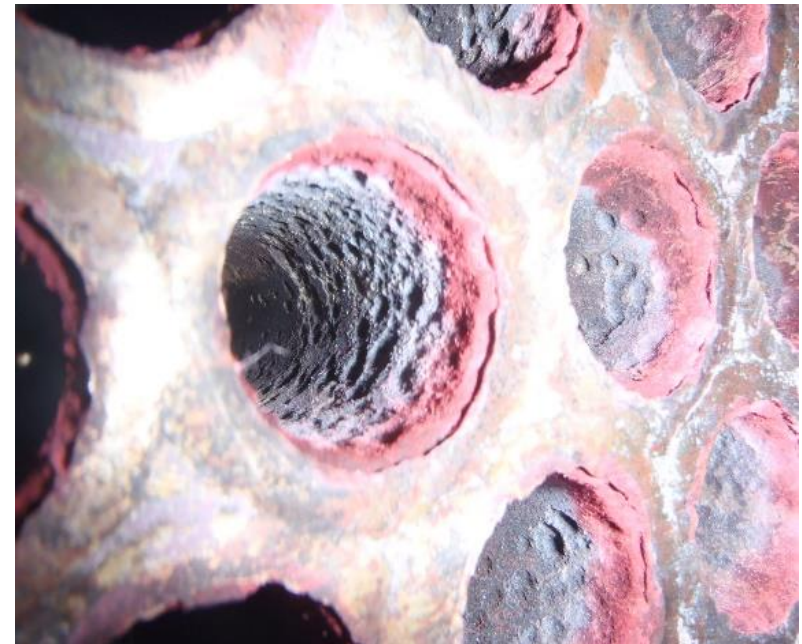
Deep pitting at tube inlet

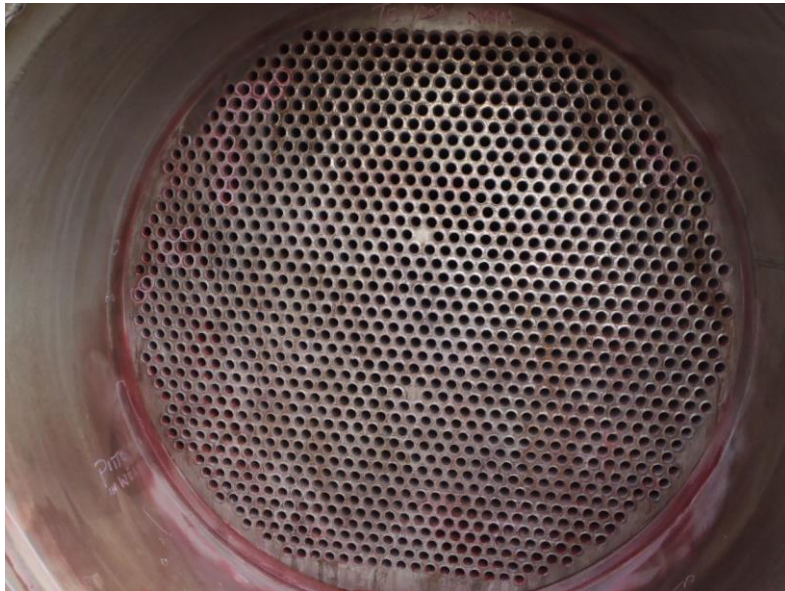
No corrosion found at tube outlet

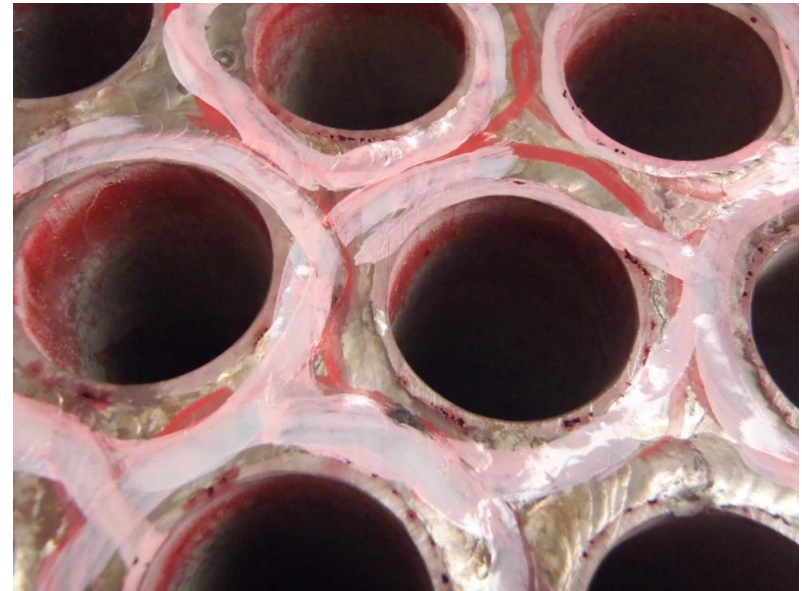
Outlet tubes are very clean

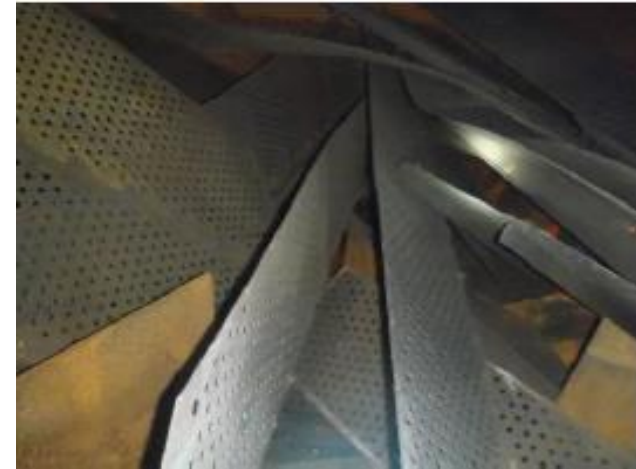
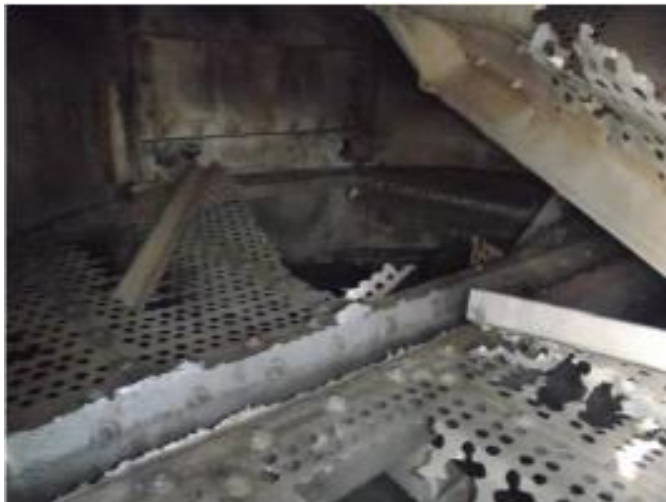
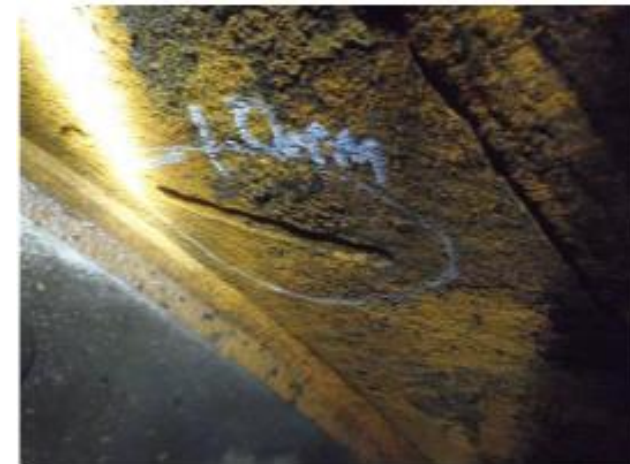
Head column:

**Collapsed, broken,
fallen down, detached
and thinned out trays.**

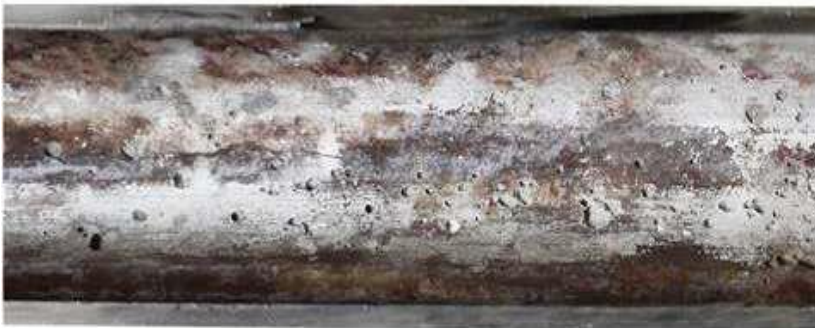
Shows inner surface view of tube at inlet portion. Scattered pitting as well as corrosion marks seen in longitudinal direction.

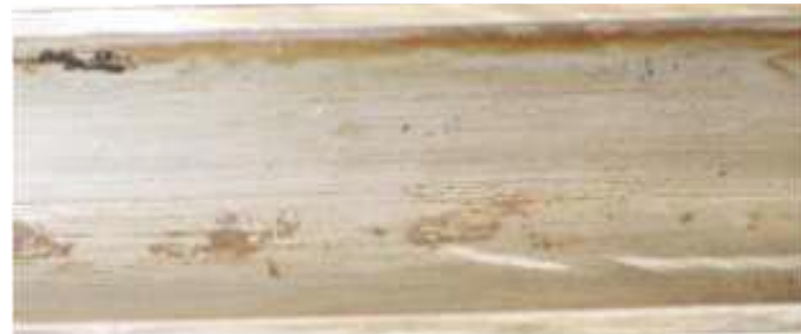
Shows inner surface near outlet end. The surface is free from any pitting corrosion damage.

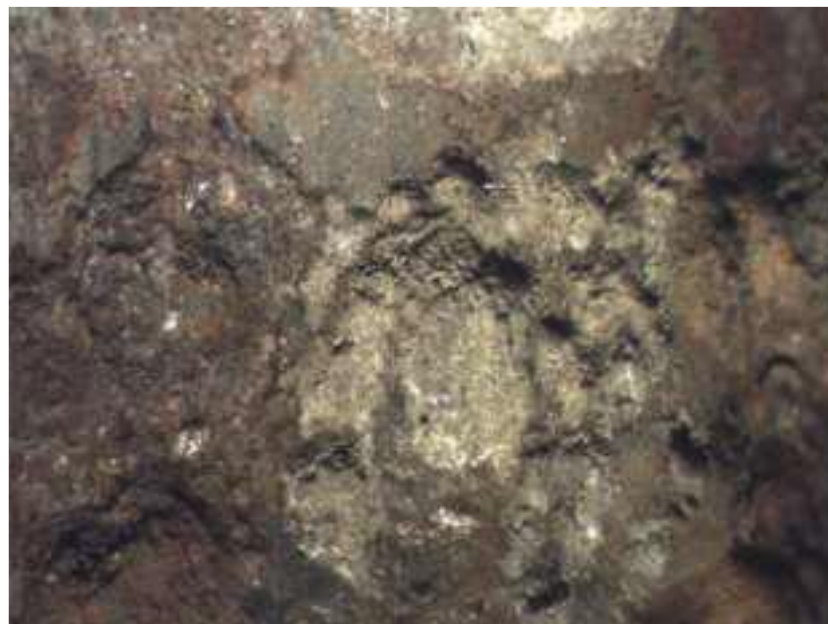
Inner surface low magnification views. Pitting corrosion is noticed which is surrounded by uneven but adherent scale on the surface.

Presence of free chloride in the EDC (tube side) that caused localized accelerated dissolution of metals resulting into pitting corrosion.

- ✓ **Controlling of chlorides of the feed which are from up stream.**
- ✓ **Controlling PH effectively.**
- ✓ **Selecting a suitable material of construction for Condenser.**
- ✓ **Importance of training/awareness and operation Practices.**
- ✓ **Avoid further damage to the asset by applying the correct practice of standard operating procedure.**

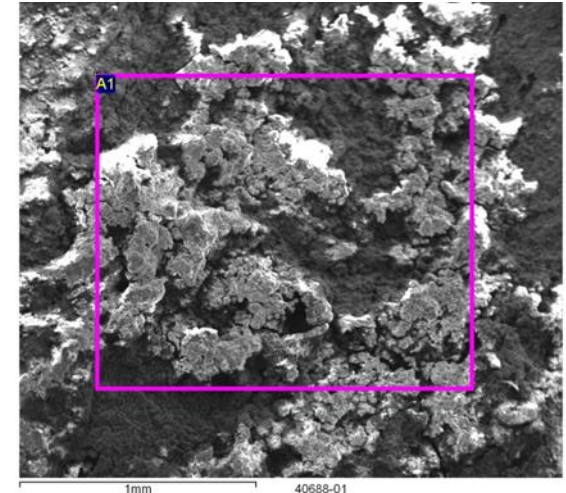
Confirmed the presence of Chloride. The tube side fluid contains chlorinated hydrocarbon. The source of Chlorine is from these chlorinated hydrocarbons. This causes the localized accelerated dissolution of metals resulting into Pitting corrosion.

PRESENCE OF HIGH PERCENTAGE OF CHLORIDE
