FRP PIPING CHALLENGES AND RELIABILITY  
IMPROVEMENT JOURNEY IN TASNEE

# CW NETWORK OVERVIEW ( GRP PIPING)

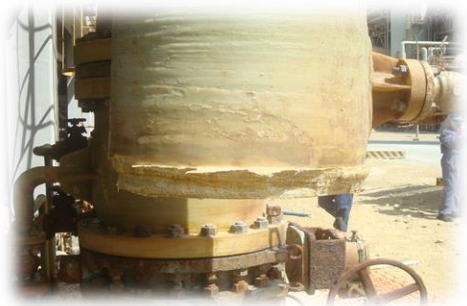
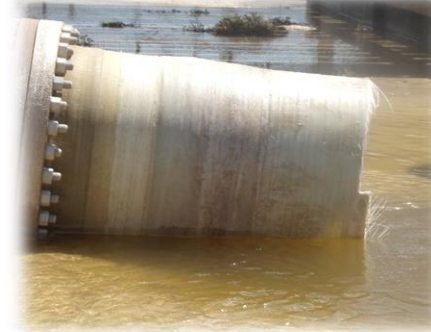
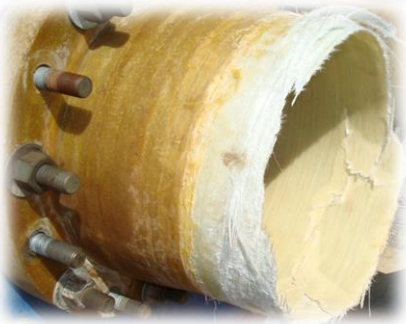
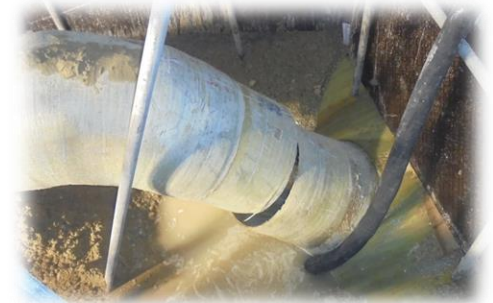
**GRP Piping**

**Utility system**

**Process system**

**Cooling Water system (CW)**

**Sea Water system (SW)**

**Waste Water (WW)**

**Chemical**

1 Failure

0 Failure

**14 Failures**

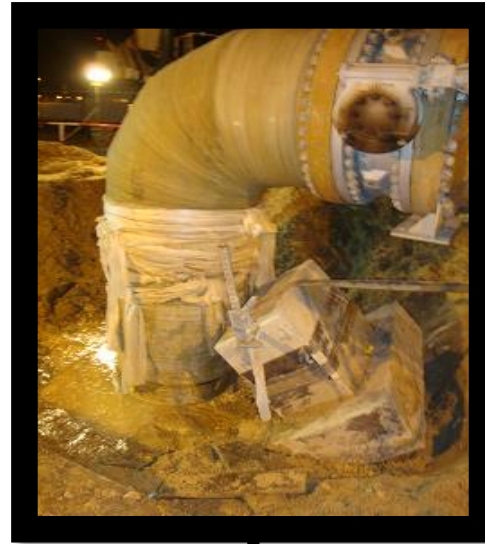
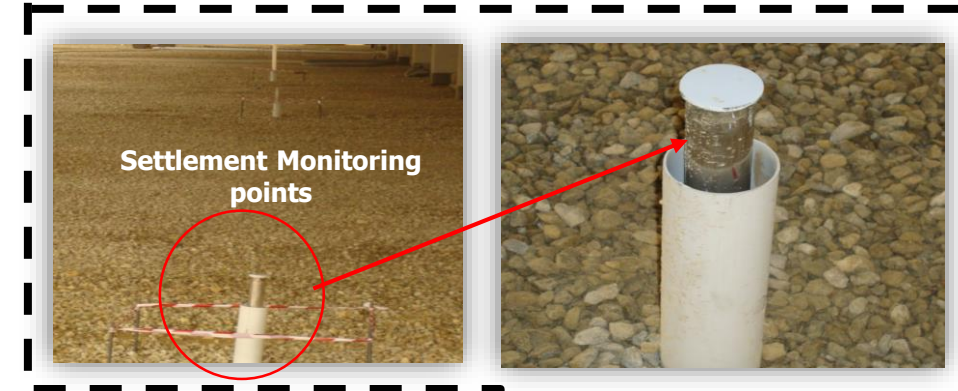
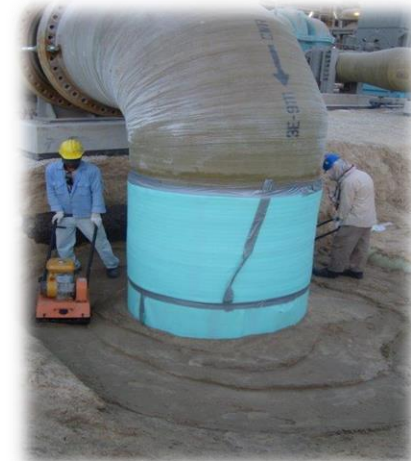
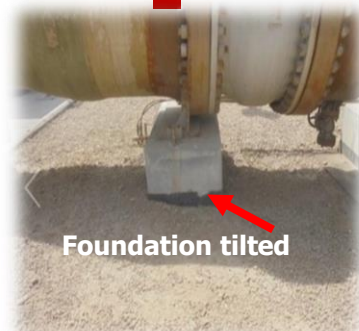
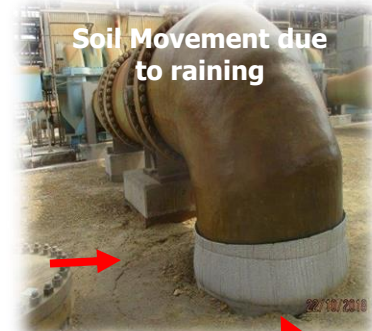
## Soil & Support Enhancement Project

## Root cause:

## Soil Settlement

## Due to:

- Lack of sufficient compaction & backfilling.
- Top soil movement due to Raining.
- Presence of underground water <2.5m depth.

## Mitigations done

- ✓ Removed soil & re-compacted.
- ✓ Developed routine PM Inspection program.
- ✓ Routine survey after heavy raining.
- ✓ Regular soil settlement survey (monthly).
- ✓ Develop QA/QC system for Backfilling work

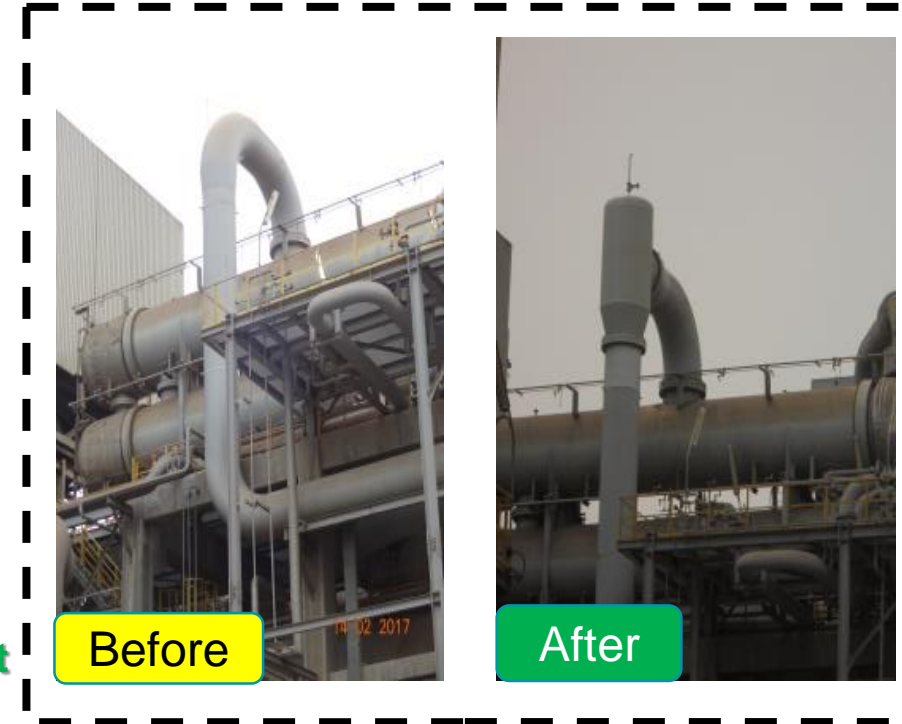
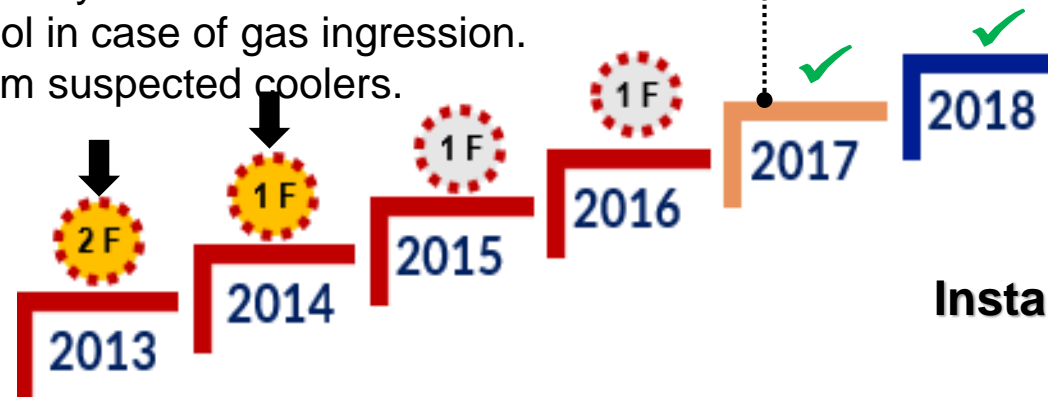
Stress issue  
Enhancement  
Project

## Root cause:

- **Gas ingress – from connected process coolers**
- **Design weakness point - Branches Tie in Joints geometry**

## Due to:

- Plant gasses ingress through heat exchangers tubes failure.
- GRP not designed for dual phase flow.
- Gas in system create stress in pipes weak points (at PHE 24” Branches)

Installed in CW loops (highest point) in each plant

## Mitigations done

- ✓ Expansion pots/vessel.(To vent the entrapped Gases)
- ✓ Enhance operation procedure and venting control.
- ✓ Monitoring for gas ingress by analyzer.
- ✓ Develop venting response protocol in case of gas ingression.
- ✓ Inspection program for CW system suspected coolers.

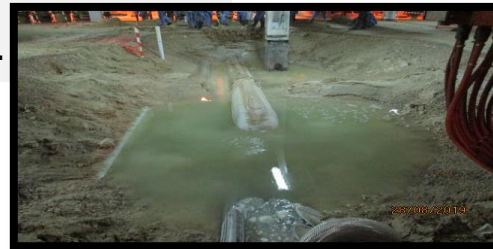
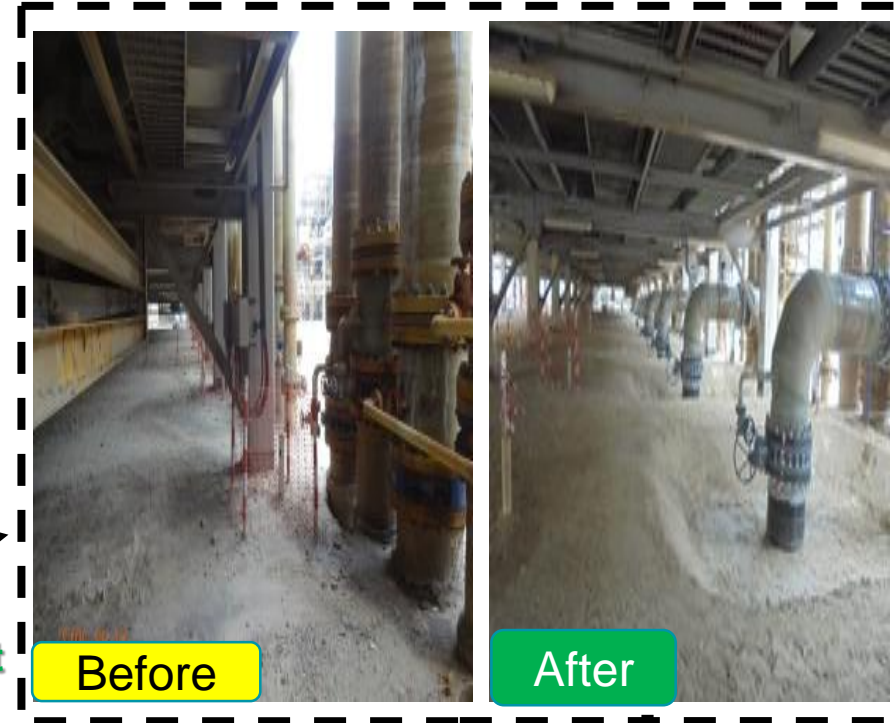
Stress issue Enhancement Project

## Root cause:

- Gas ingress – from connected process coolers
- Design weakness point - Branches Tie in Joints geometry

## Due to:

- Stress coming from Piping Support design.
- Branch geometry have weak points easy to fail with external stress factor.
- Piping Lower axial tensile strength.

## Mitigations done

- ✓ Upgrade the pipe to GRV.
- ✓ Additional lamination done to enhance axial strength.
- ✓ Re-routed of highly stressed lines.
- ✓ Add exp. bellow to absorb stress from weak points.
- ✓ Flow velocity < 3 m/sec as IOW limit

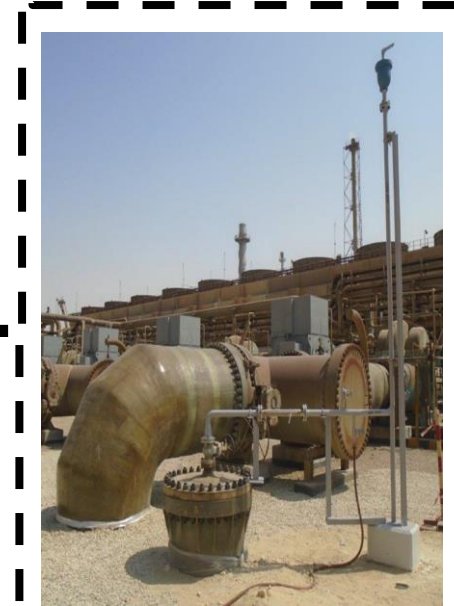
## Root cause:

- Gas ingress and accumulation in dead zone
- High Material degradation - Manufacturing issues

## Due to:

- Plant gasses ingress through heat exchangers tubes failure.
- GRP not designed for dual phase flow.
- No auto-venting system in piping dead zone (manway & isolated valve).

## Mitigations done

- ✓ Enhance operation procedure and venting control.
- ✓ Provide Auto-vent system for all network manway.
- ✓ Include isolated valve in venting check list
- ✓ Develop guideline

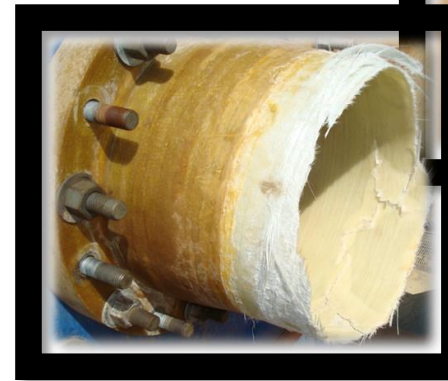
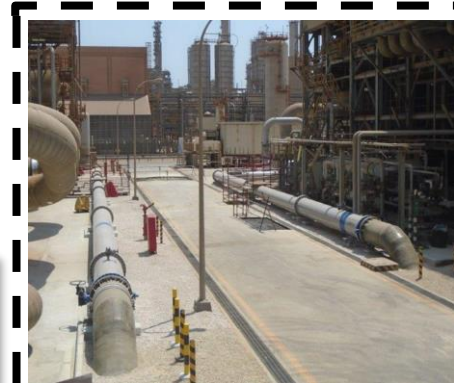
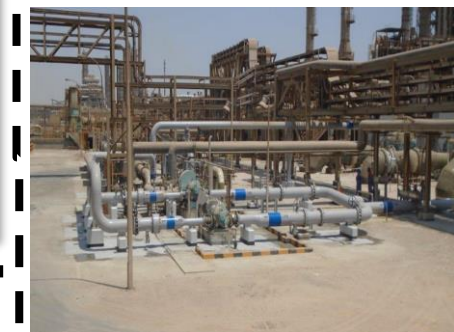
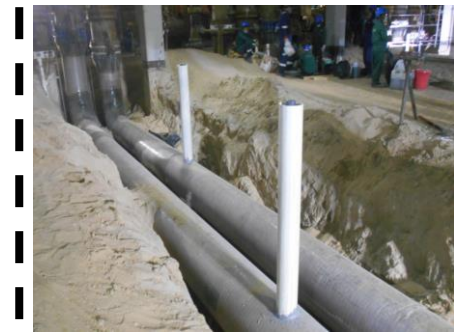
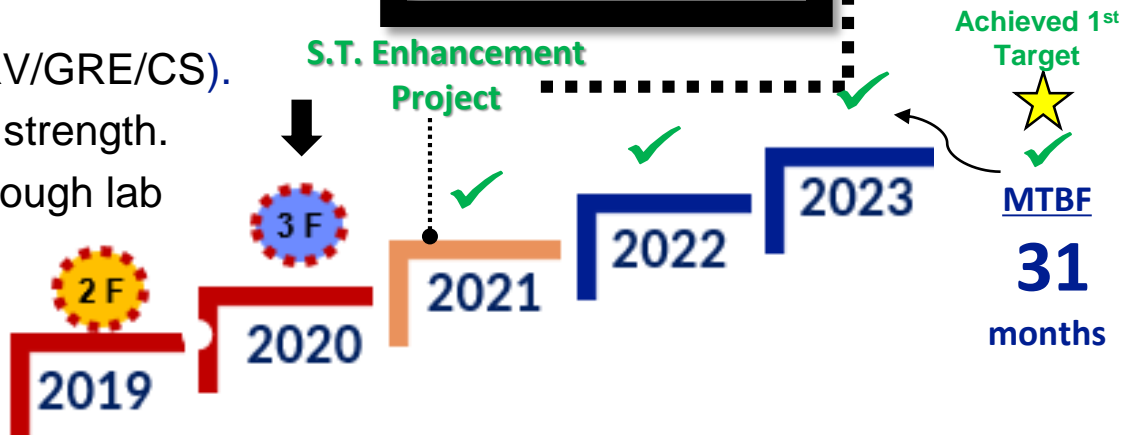
## Root cause:

- Gas ingress and accumulation in dead zone
- **High Material degradation - Manufacturing issues**

## Due to:

- Axial & Bending Strength < min. required values.
- Internal corrosion barriers damage
- Air bubbles converts to blisters during in service.
- Blister presences accelerate further deterioration of piping strength & leads to crack.
- External UV Protection barriers damage.
- Consider only long-term safety factor in calculation.

## Mitigations done

- ✓ Replaced with upgraded materials (GRV/GRE/CS).
- ✓ Additional lamination done to enhance strength.
- ✓ Deep assesment for GRP network through lab analysis.

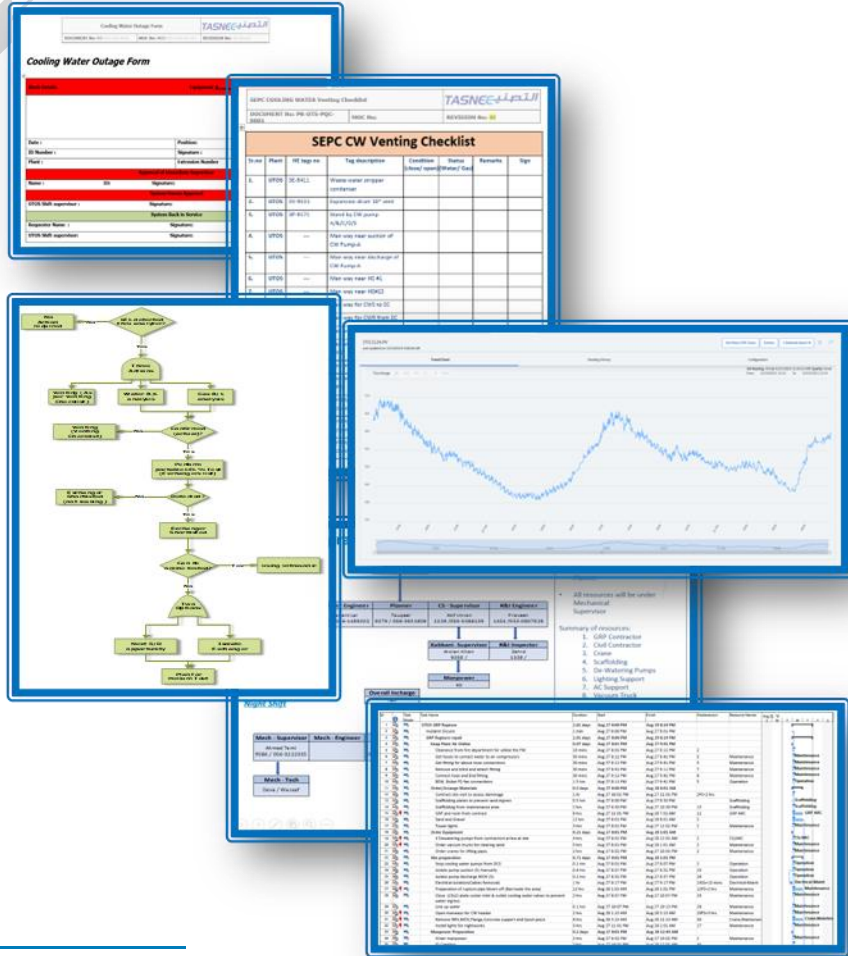
# CW GRP CONTROL MEASURE PROGRAM

Gas ingress/  
Pressure Surge  
event

Material  
properties  
degradation

- ✓ Enhance operation procedure and venting control
- ✓ Continuous monitoring for gas ingress by analyzer
- ✓ Auto venting system for all dead zones
- ✓ Continuous venting incase of gas ingress
- ✓ Inspection program for CW system suspected coolers

- ✓ Replaced with CS piping
- ✓ Rerouted to above ground in process area
- ✓ Replaced with GRV for high affected underground piping
