JUBCOR

2024

Field Applied Solutions for
Corrosion Challenges in
Amine Systems

Presented By:
Rohit Kardile

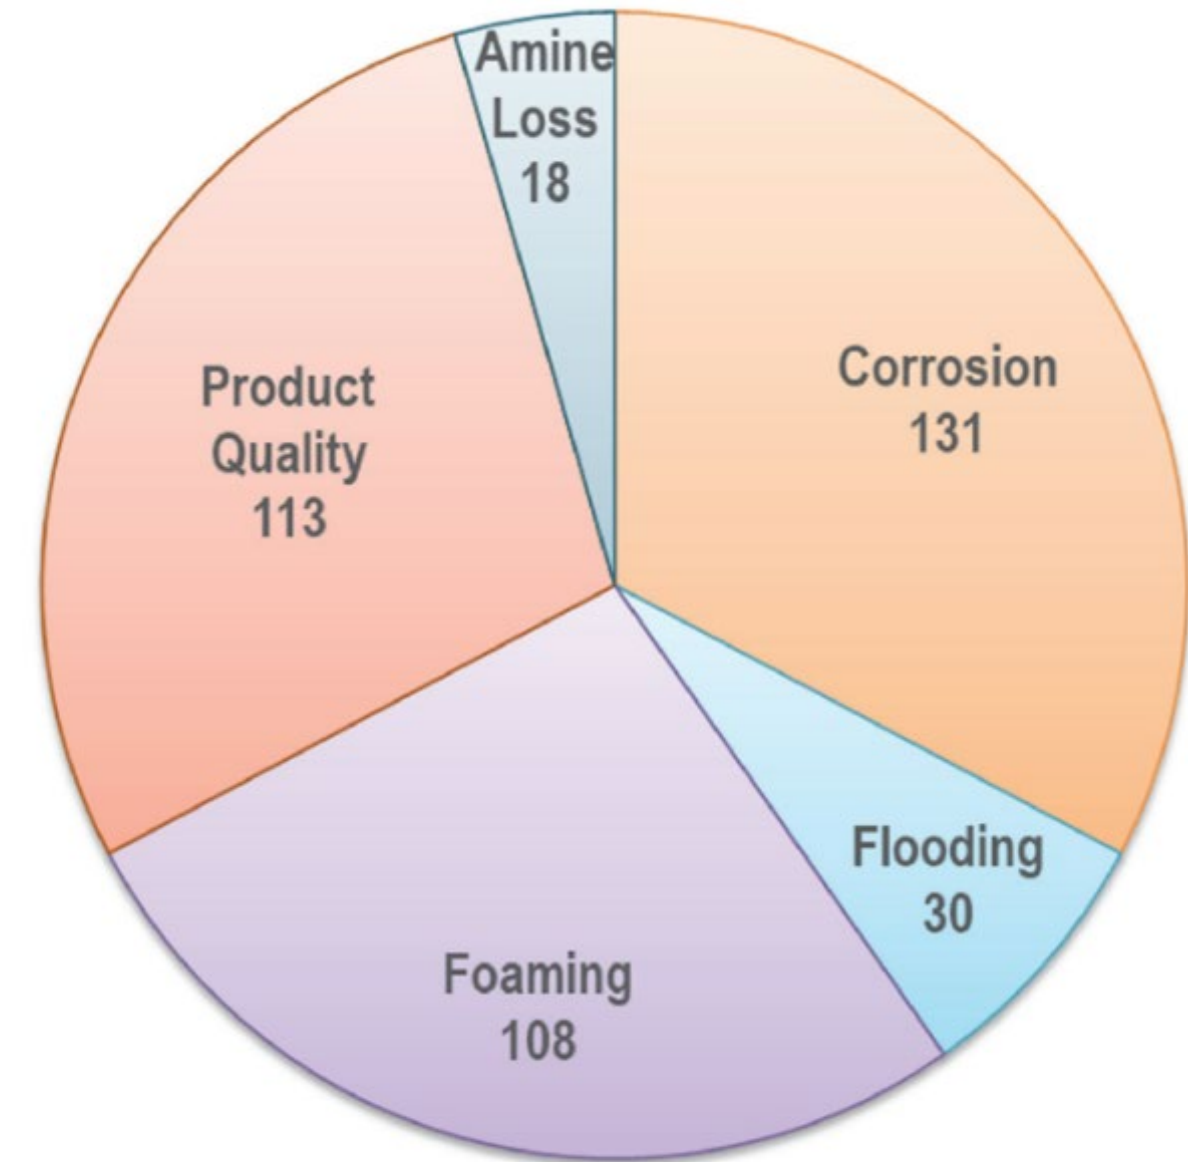
Cases of critical failure by type for all amine systems (sweet and sour)

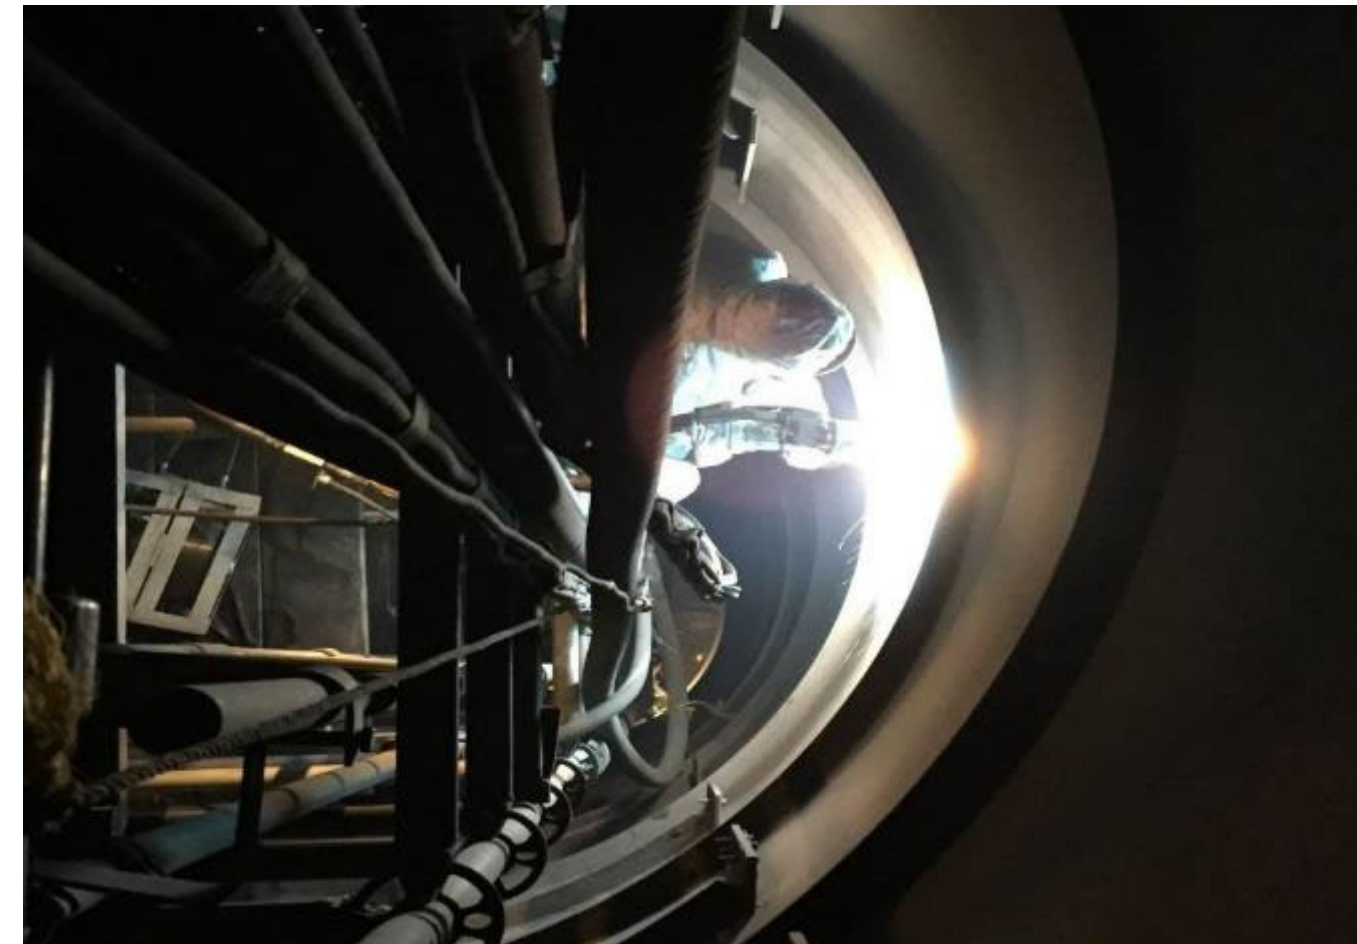
MDEA AMINE COLUMNS

Train 4 outage in March of 2015, metal-wastage problems in Amine Columns 24-C0903 and 24-C0901 were addressed.

The interior surface of the shell was in a bad condition and required extensive grinding. The total area clad was 143m² in the top sections of both columns.

IGS HVTS cladding was applied to the vessels where the severe pitting corrosion was identified, to protect from further metal wastage and wall loss.

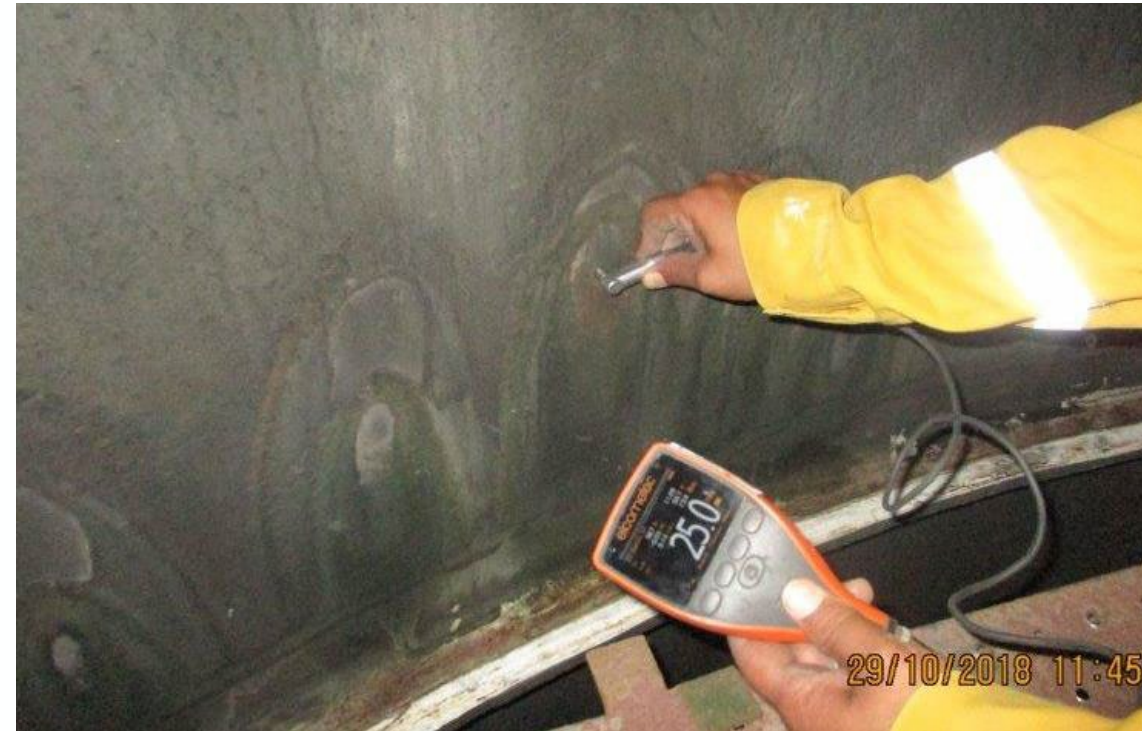
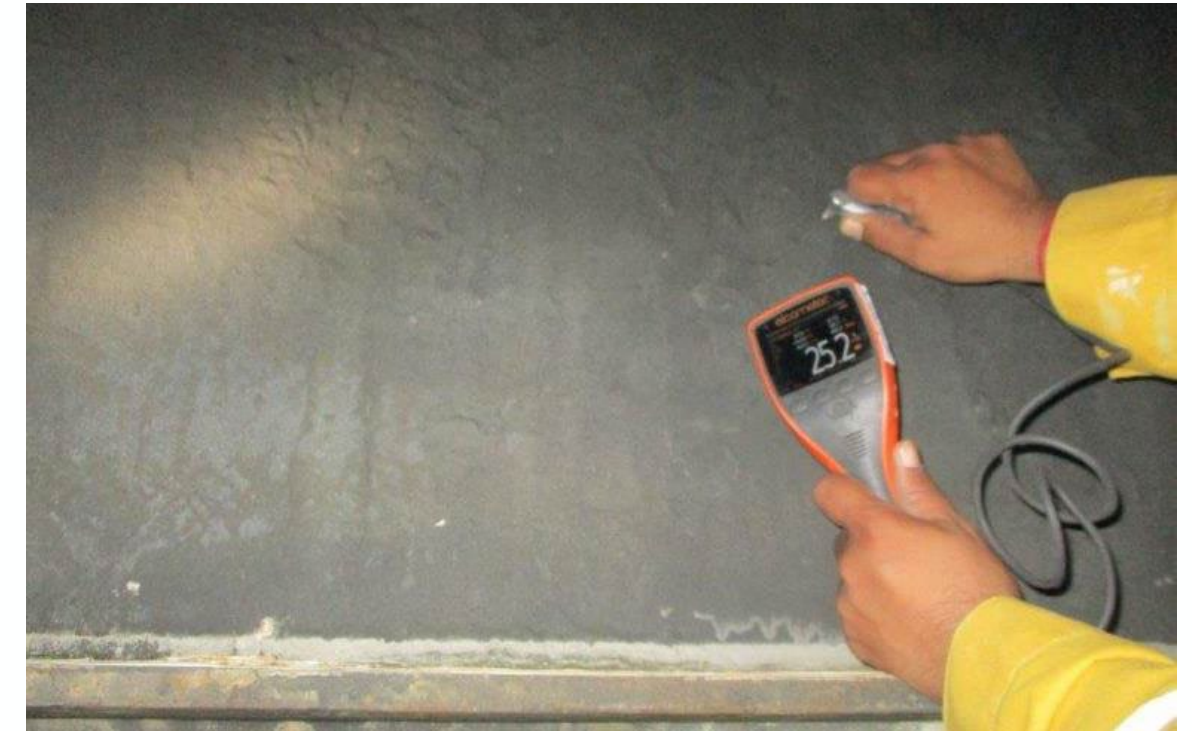
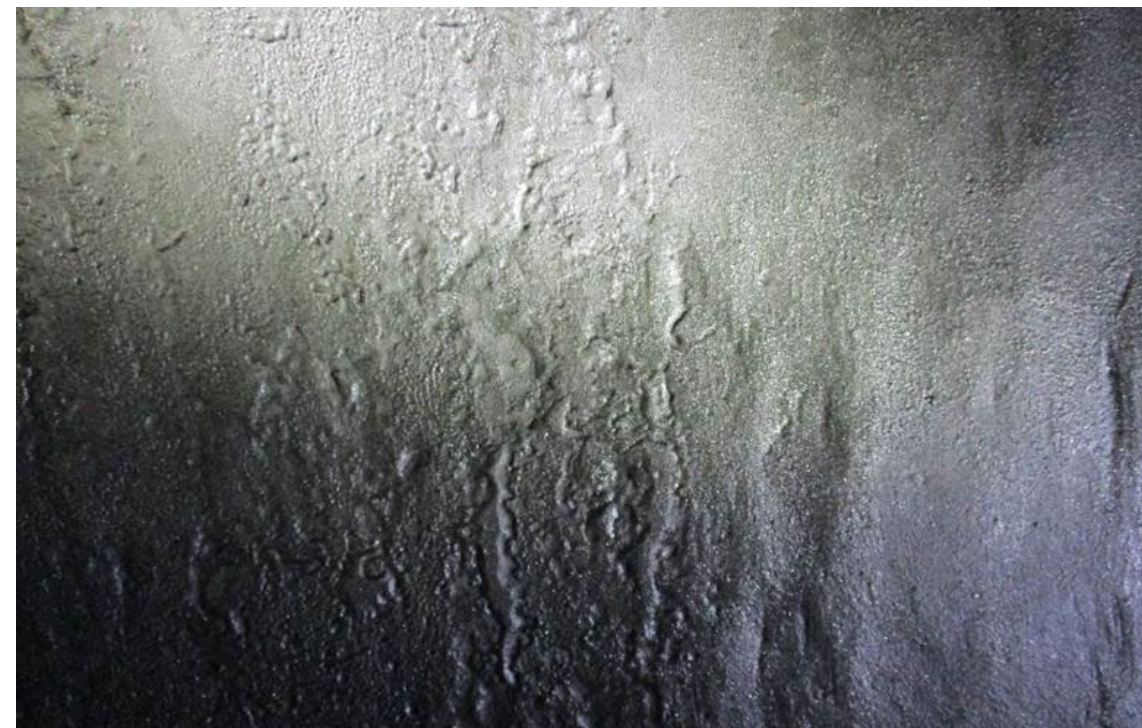
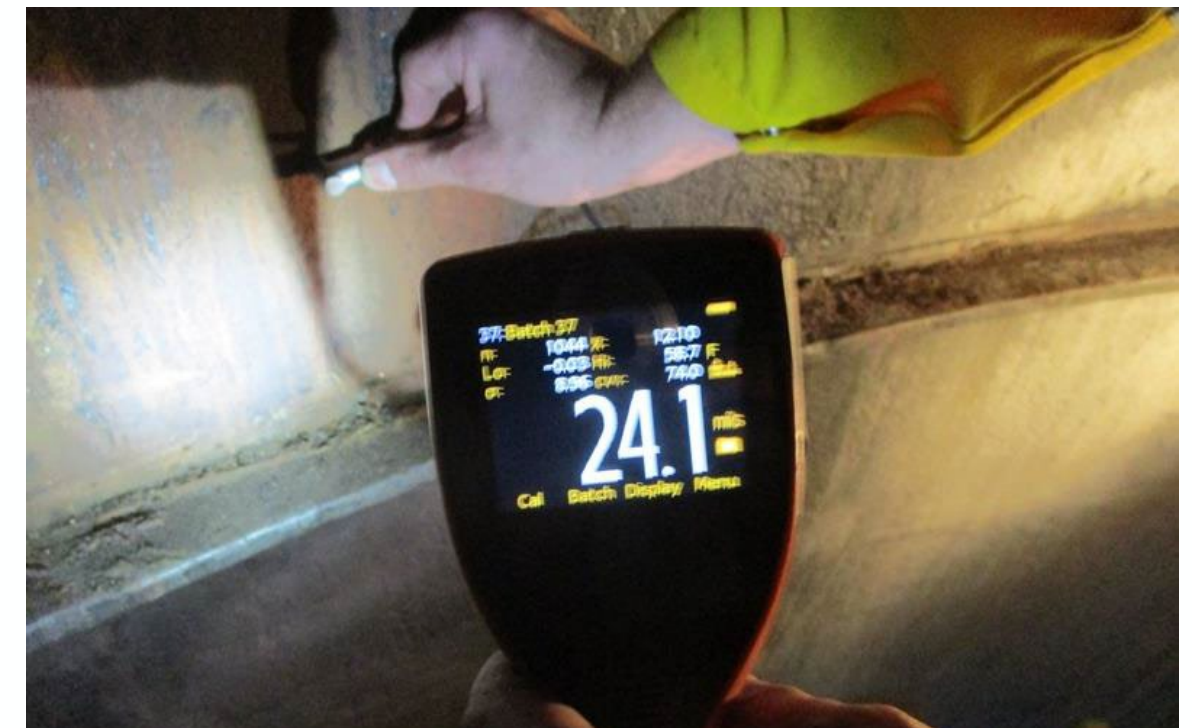
Inspection, October 2018

“The HVTs cladding was found to be in very good condition. The cladding is unaffected after three years of service and has effectively protected the internal metal surface thus freezing the condition of the shell. The cladding condition was the same as the day it was applied in terms of visual appearance and thicknesses.”

- No repairs required.

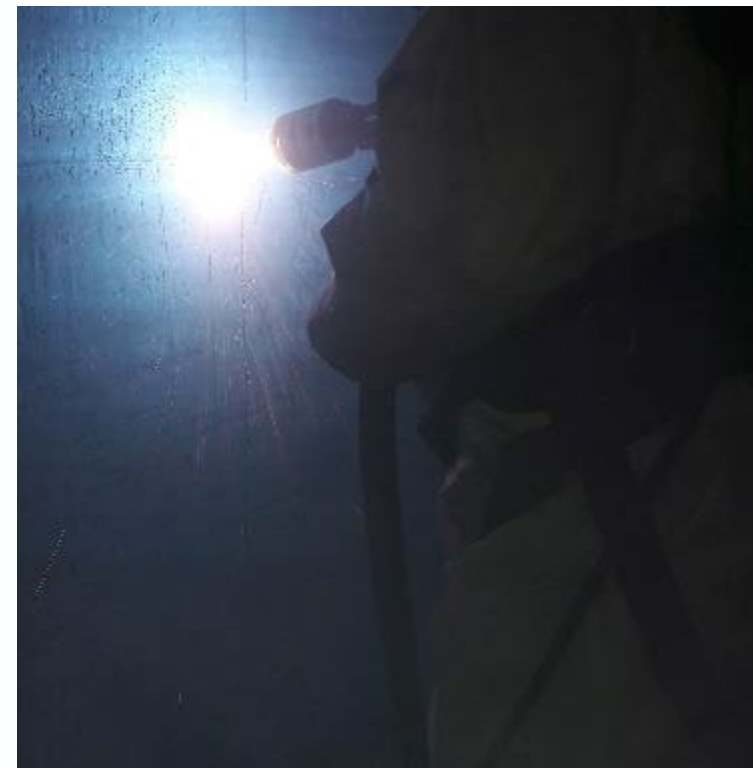
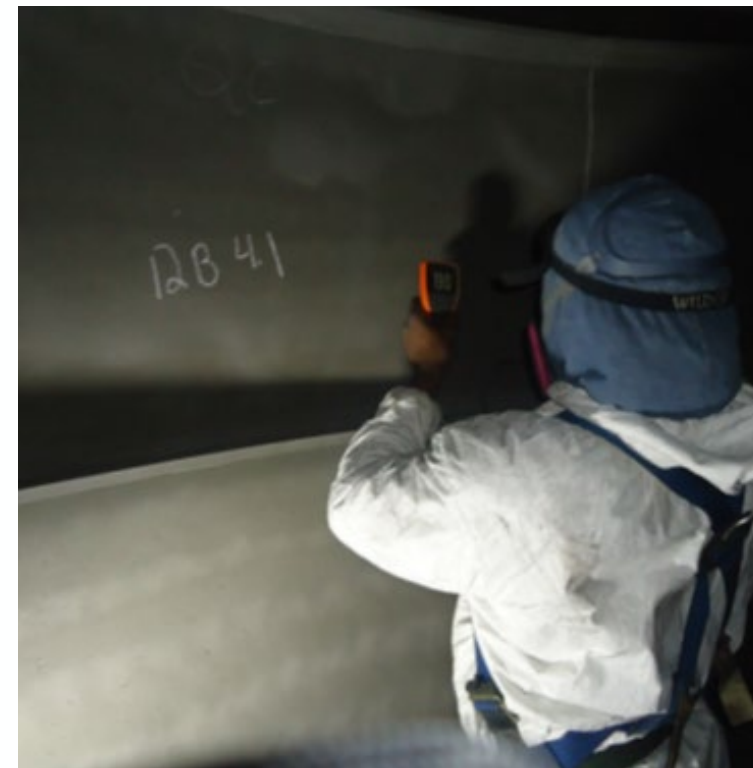
AGR AMINE ABSORBER TOWERS

During inspection in 2011 significant pitting corrosion was discovered in various assets e.g. unclad carbon steel sections of AGR Amine Absorbers below the CRA weld overlay and in other discrete locations.

IGS HVTS 5420 cladding was applied to the vessels below the CRA weld and in other discrete locations where pitting corrosion was identified.

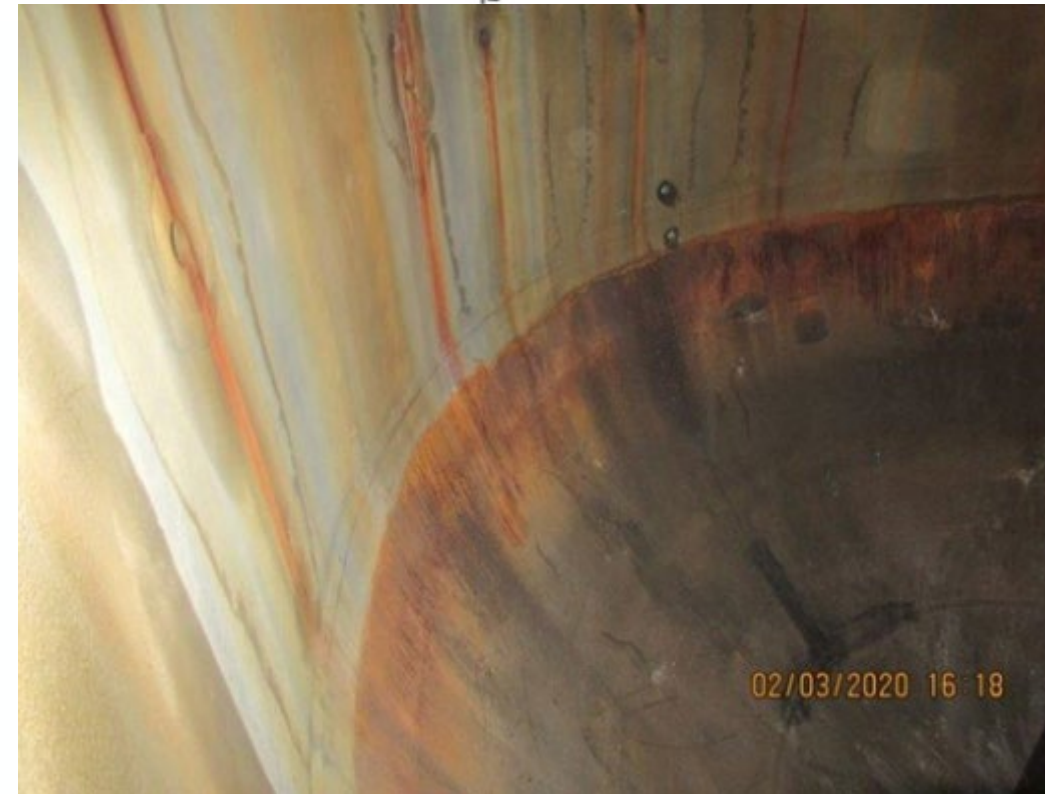
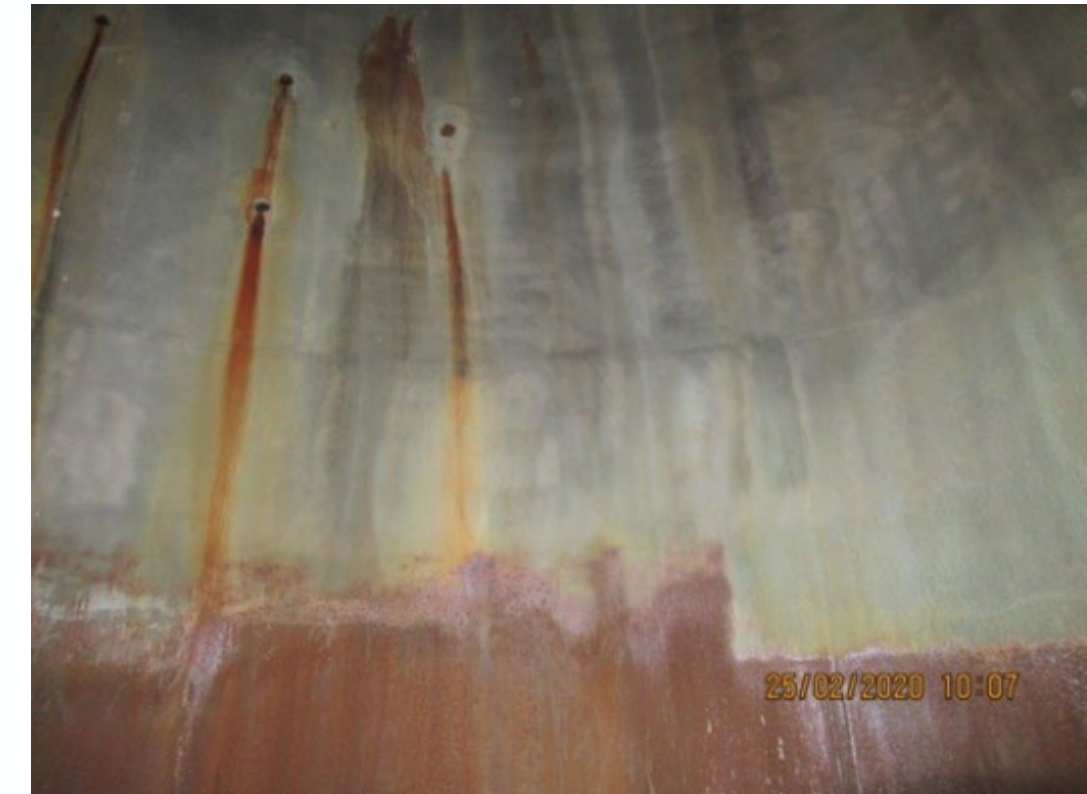
Inspection:
February 2020

- Inspection Results:
IGS HVTS cladding is in excellent condition.
- No repairs required.

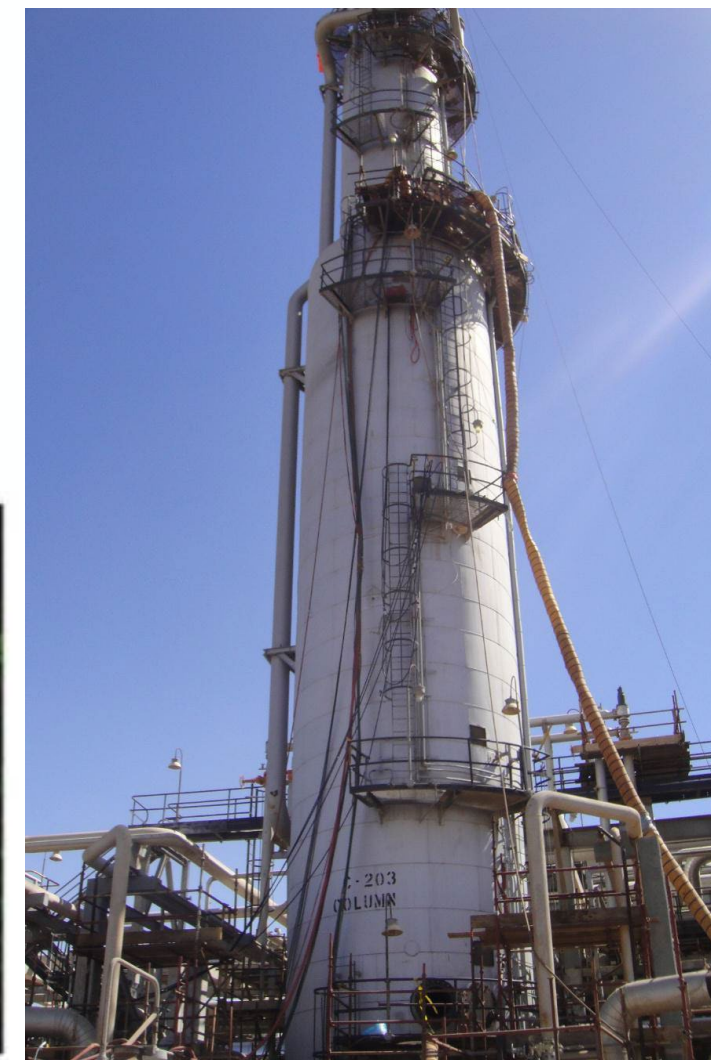
Gas Plant
De-Ethimizer
Column

- De-Ethimizer column built in 1975 from non-HIC resistant material, suffering from Sulphide Stress Cracking (SSC).
- Internal H₂S (sour) corrosion activity generating atomic Hydrogen which diffused into the metal substrate, leading to hydrogen embrittlement, blistering and stepwise cracking due to Hydrogen Induced Cracking (HIC).

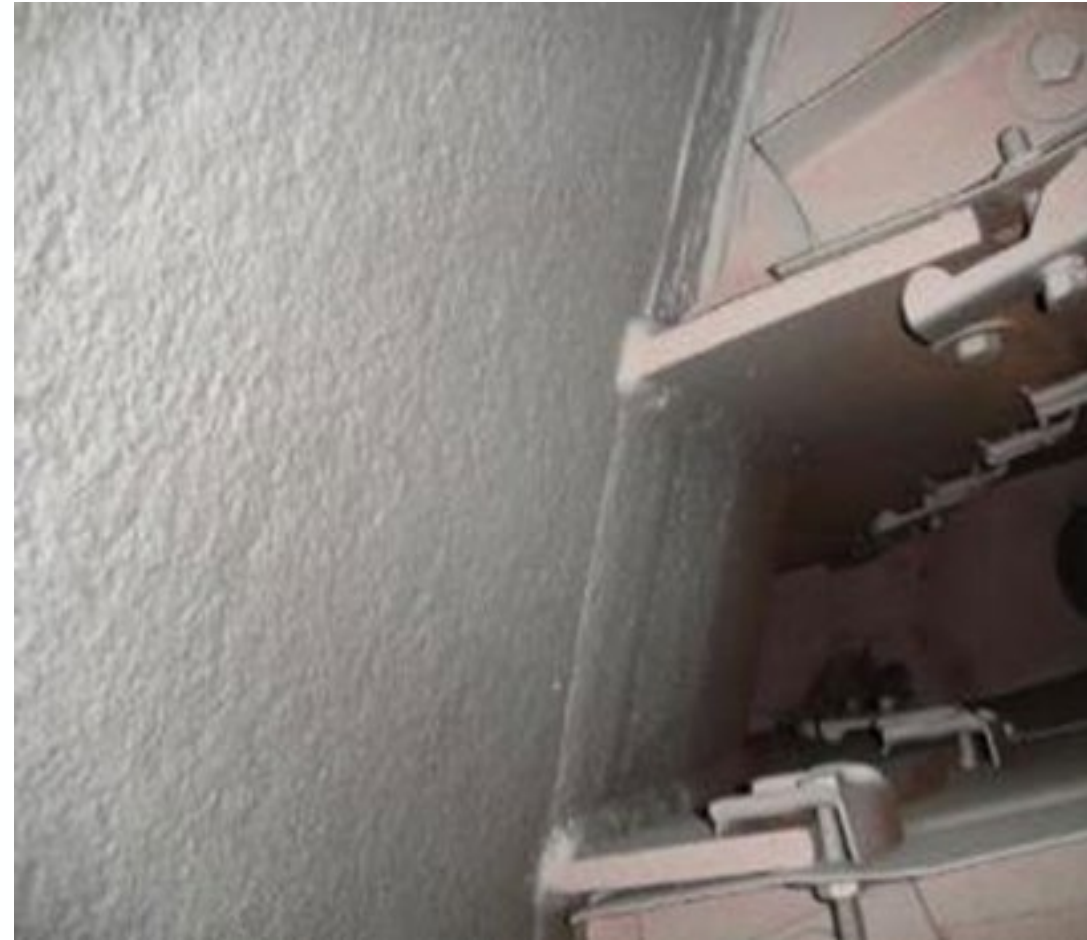
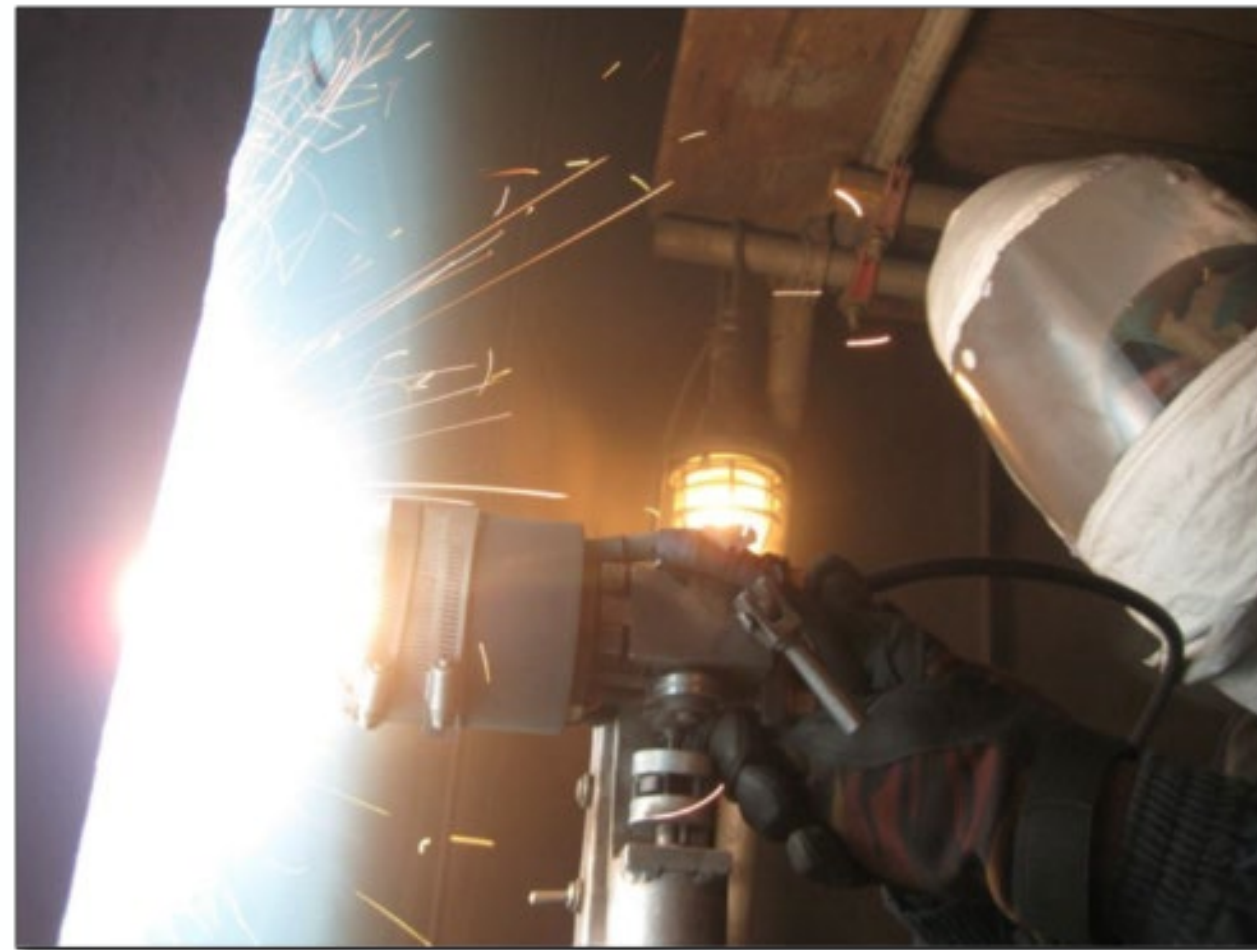
**NACE Corrosion 2015
Paper, No. 5952:
Application of HVAS
Cladding to mitigate
Sulfide Stress Cracking and
Hydrogen Induced
Cracking in a De-ethanizer
Column**

Inspection identified the existing cracks with WFMPT, followed by grinding out cracks, engineering assessment of cracks >15mm, cleaning, preheating and welding with baked electrodes, with final WFPMT to ensure no new or remaining cracks were present.

Once this process was completed all pressure bearing surfaces and welds of the column were clad with IGS HVTS (an area of approx. 635 m²), applied to protect the carbon steel surfaces and internal welds from sour corrosion and prevent further Hydrogen atom generation. The application was completed in **November 2013**.

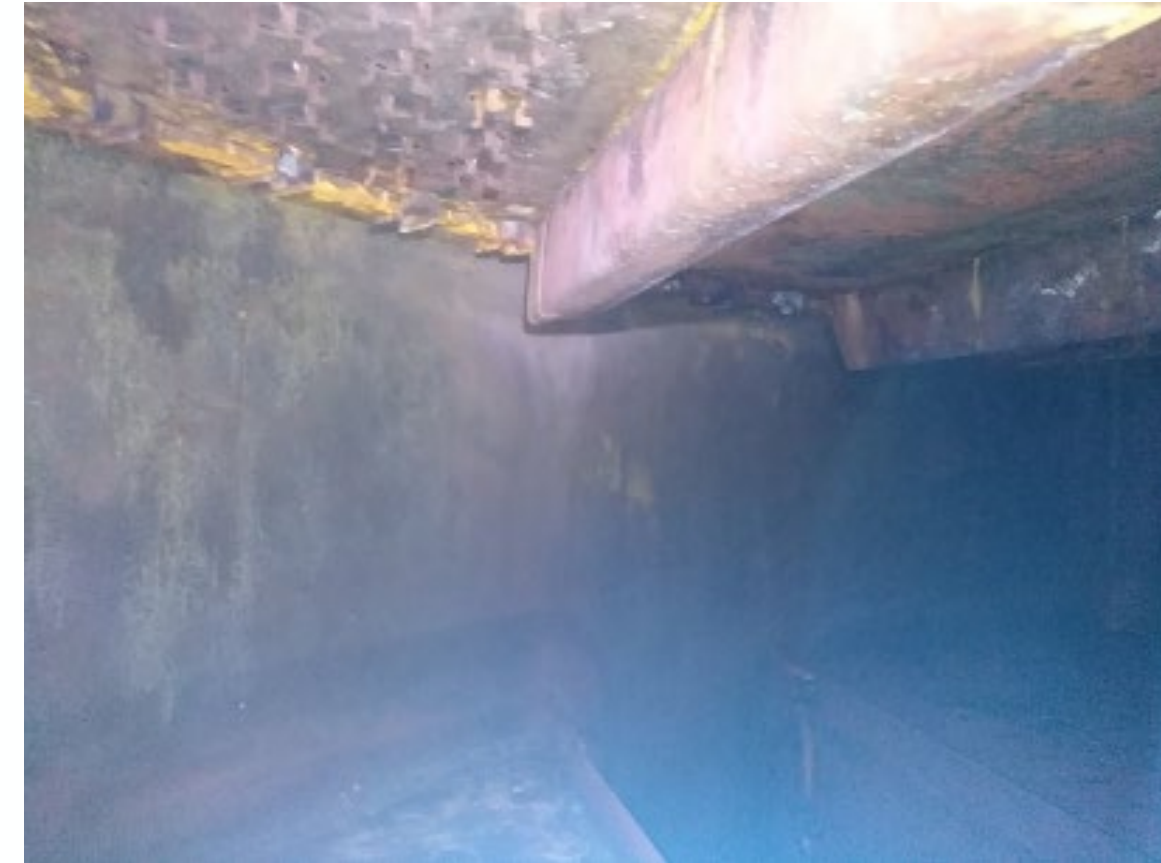
The column was shut down again at the beginning of **August 2018 and July 2023**, for maintenance and cladding inspection. The column was cleaned and inspected by IGS and client inspectors. No damage or hydrogen induced cracking was noted on the shell, welds or tray supports of the column.

Inspection images from August 2018.

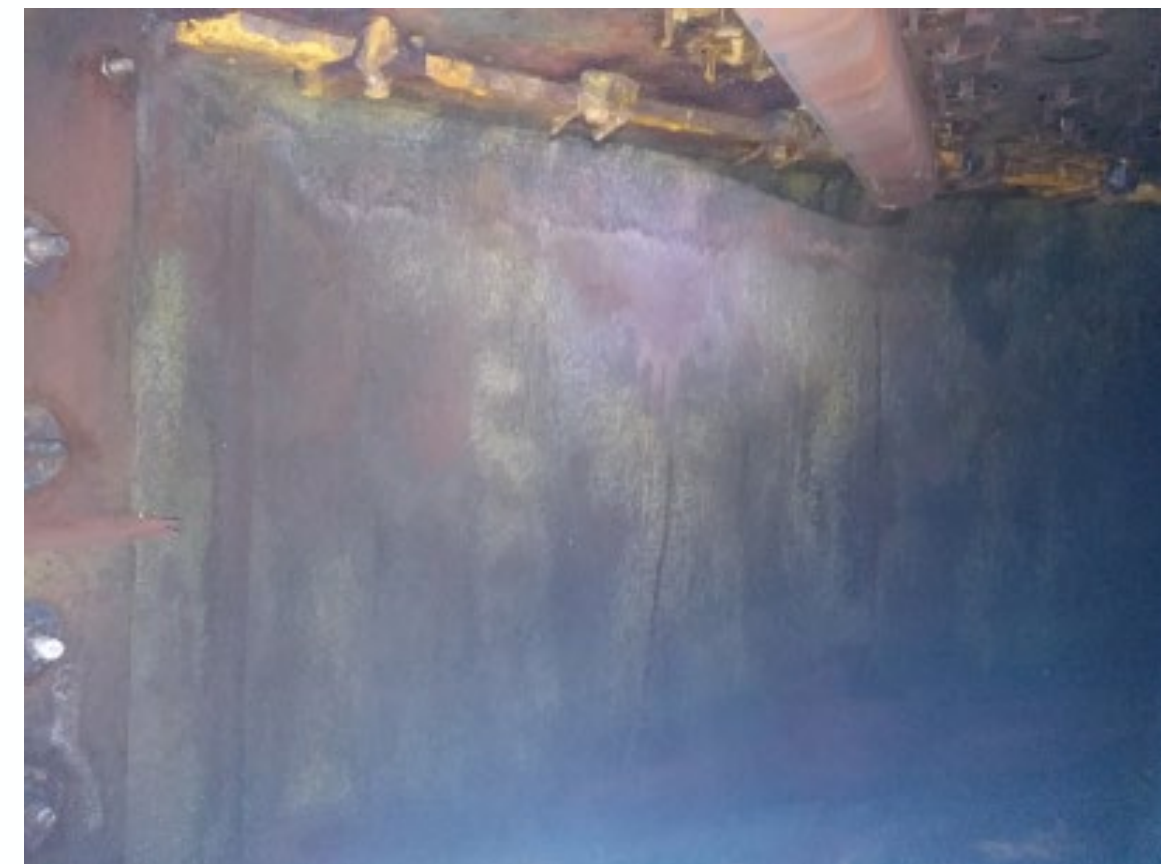
The application of IGS 5420 HVTS cladding is clearly serving its purpose to prevent active corrosion, Sulphide Stress Cracking (SSC) and Hydrogen Induced Cracking (HIC) in the fillet welds of the tray supports. After approximately **10 years of operation**, the IGS HVTS cladding has not deteriorated in any shape or form.

Inspected again in July 2023.
