On-Line Repair Solutions for Corrosion Under Insulation

NACE Jubail Technical Workshop
Corrosion under Insulation
10th December 2015

Presented By : Mr Rob Dawson

Hajjan Trading & Industrial Services Co. Ltd. (HATCON)

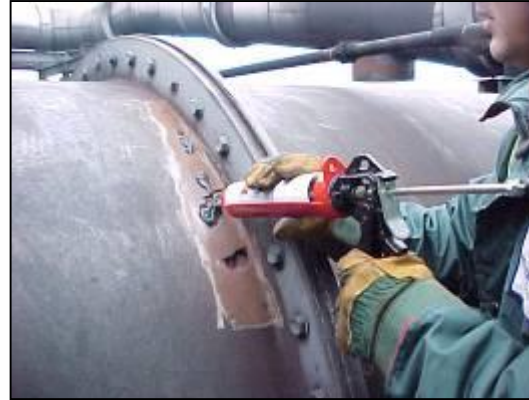
Filling of Pitting Corrosion

**HA – Metal
Paste Grade**

**HA – Barrier
Coating Grade**

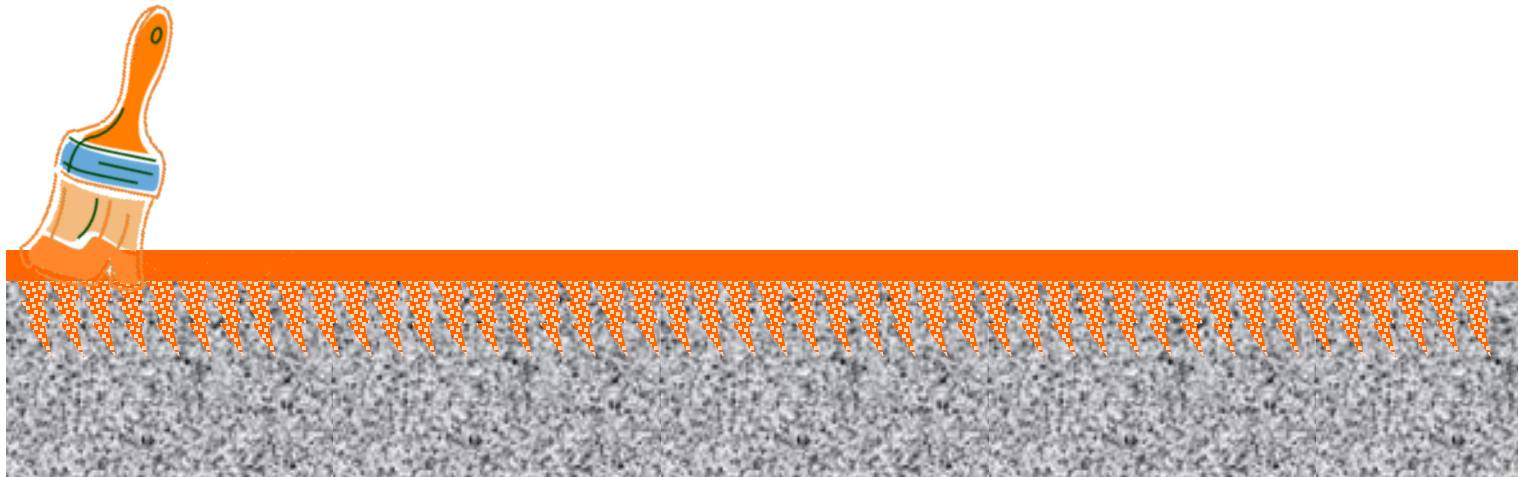
Adhesion on hot surfaces

Achieved by penetration of micro-pores in metal which increase in size on heating

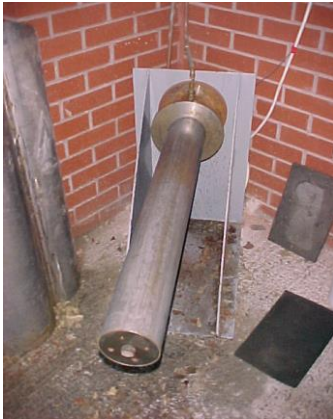
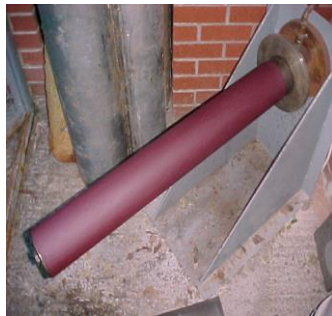
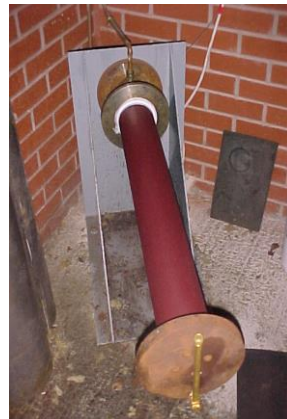
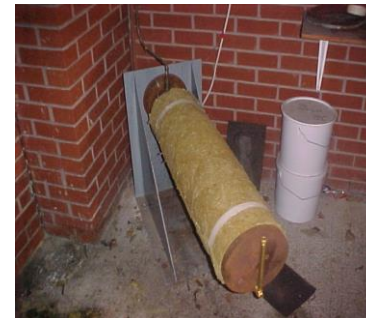
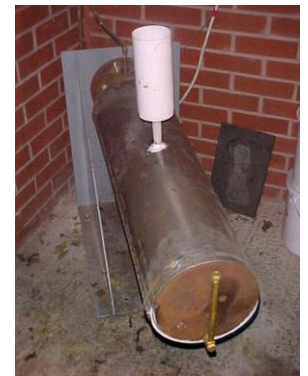
CUI Simulation Testing

- Partially rusty test sleeve manually abraded using P36 abrasive paper is placed over heater.
- Test coating is applied onto the hot sleeve.
- End flange is bolted on and sealed.
- Mineral fiber insulation taped into place.
- Outer cladding/water funnel attached/sealed.

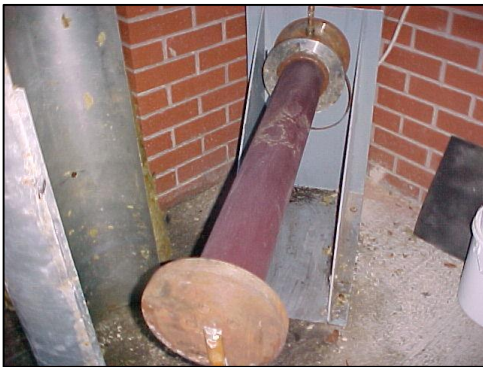
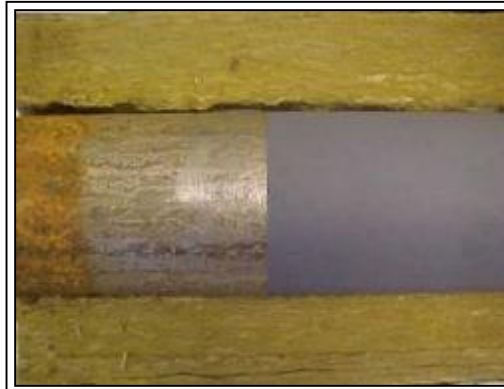
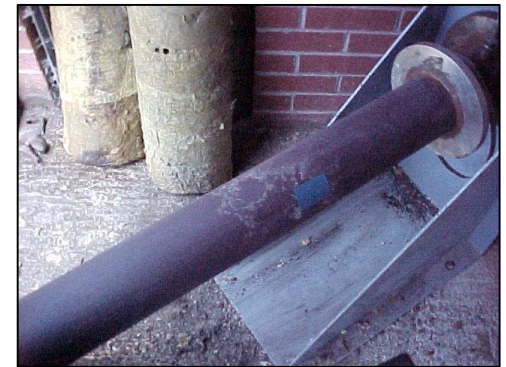
CUI Simulation Test Results

➤ Two litres of water added each week

1 litre of water and 1 litre of 5% salt water solution

No attack or corrosion at 70°C to 90°C

Negligible attack/corrosion at 100°C to 150°C

Very slight surface erosion in full immersion areas Belzona®5851

No attack or corrosion in full immersion Belzona®5841

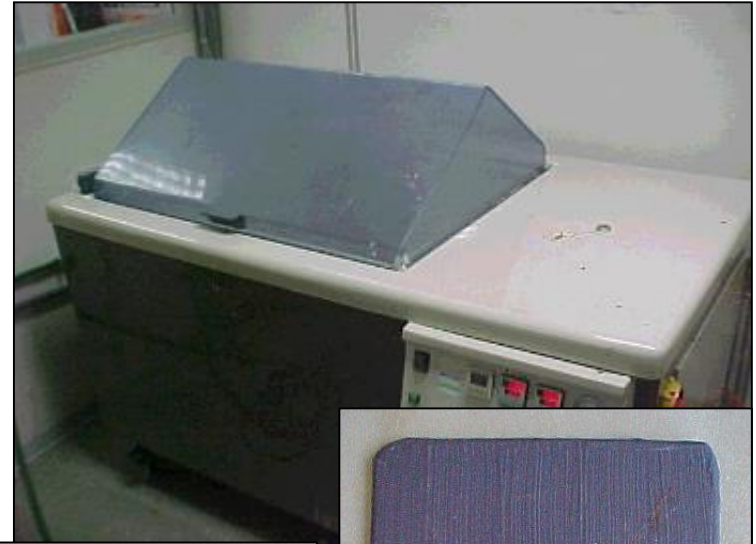
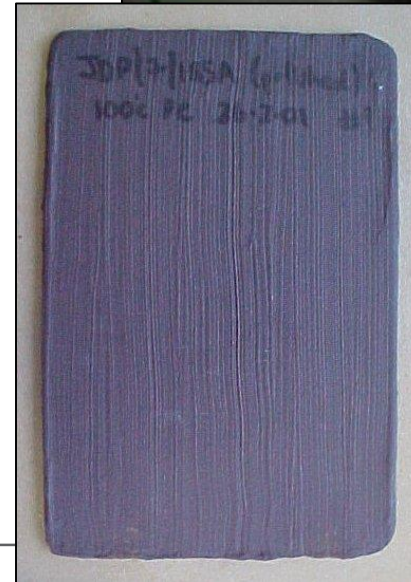
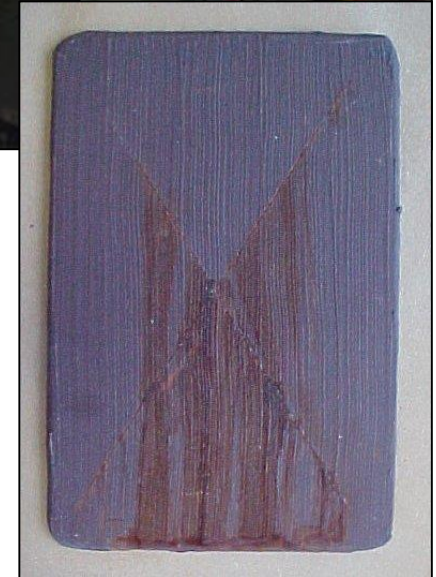
Salt Spray Results

Generates a very corrosive fog of warm salt water
Coated panels are exposed to the salt water fog,
with a scribed "X" cut through the coating
Tested in accordance with ASTM B117
Test not ideally representative of CUI but industry
standard test for corrosion resistance

Steel test panels prepared by abrading manually
(no profile)
HA Coating applied onto hot panels and oven
cured
Panels exposed for 1000 hours at 35°C (95°F) in
saturated salt fog atmosphere

No field blistering or corrosion
Minimal corrosion creep under the
scribe mark

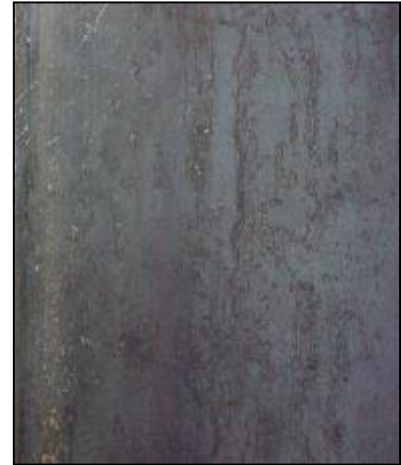
Unprepared Steel

Unprepared, uncorroded steel direct from the manufacturers.
Surface covered in firmly attached millscale.

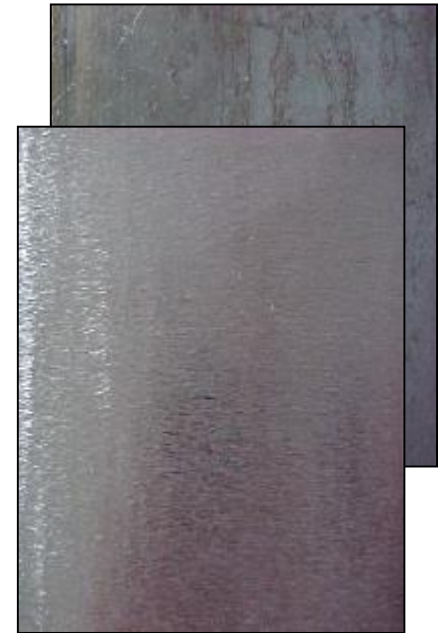
Ground Steel

Unprepared steel ground using belt sander (with P36 abrasive).
Clean metal surface exposed, but negligible profile.

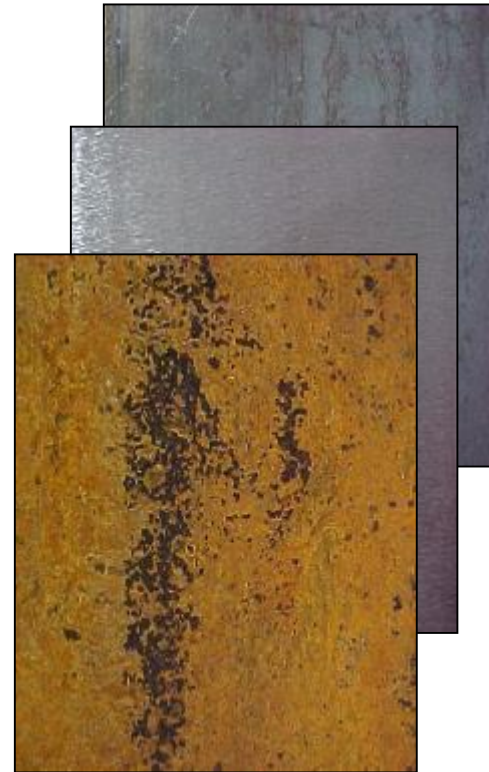
Rusty Steel

Steel weathered externally for 3 months. Rusted to ISO 8501-1 grade C, i.e. significant rusting with some pitting.
Loose surface rust brushed away, but no other preparation.

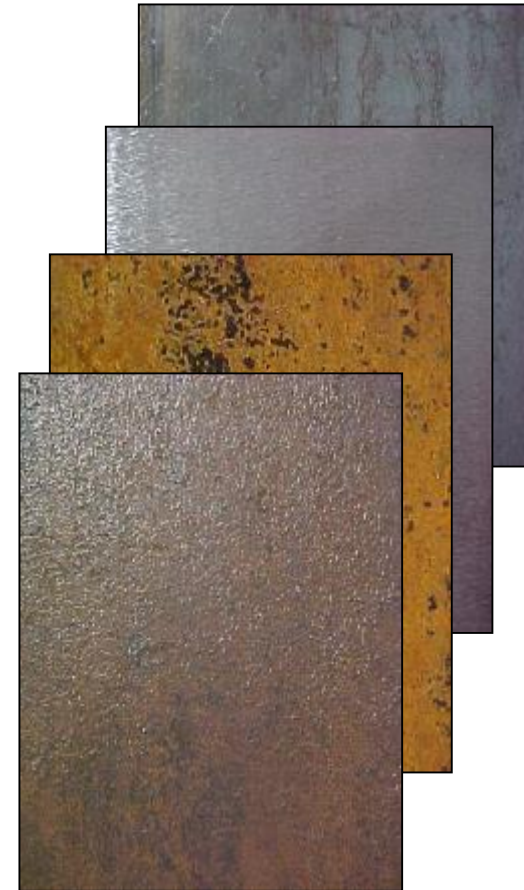
Wire-Brushed Rusty Steel

Started with rusty steel panel (ISO 8501-1 grade C)
Thoroughly abraded with wire brush to ISO 8501-1 St 2.
Pitted surface covered in firmly attached rust.

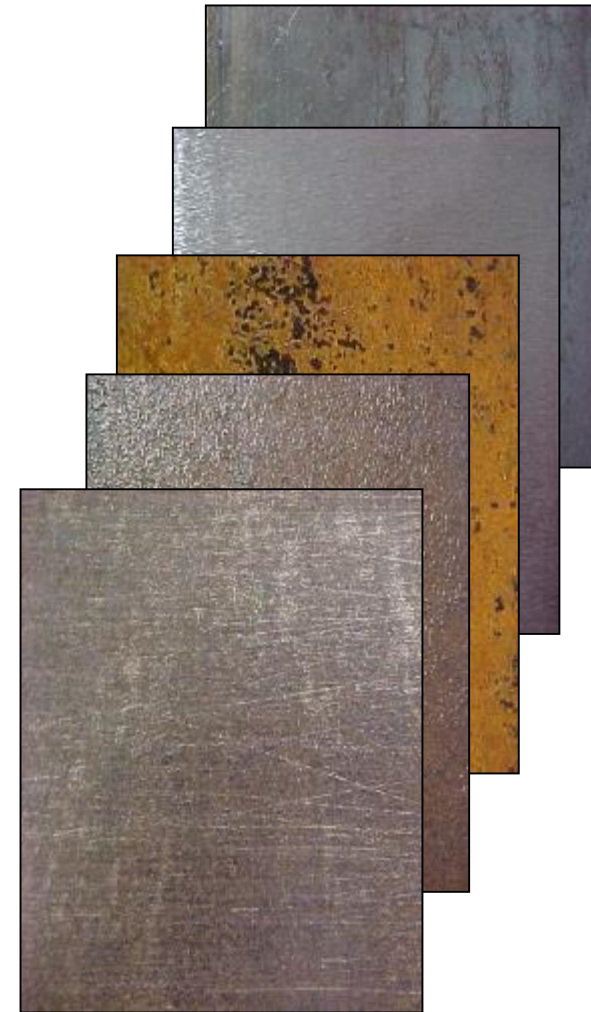
Abraded Rusty Steel

Started with rusty steel panel (ISO 8501-1 grade C)
Initially abraded with wire brush, then further abraded by hand with P36 abrasive paper to ISO 8501-1 St 3 surface;
a combination of firmly attached rust with some clean steel showing through.

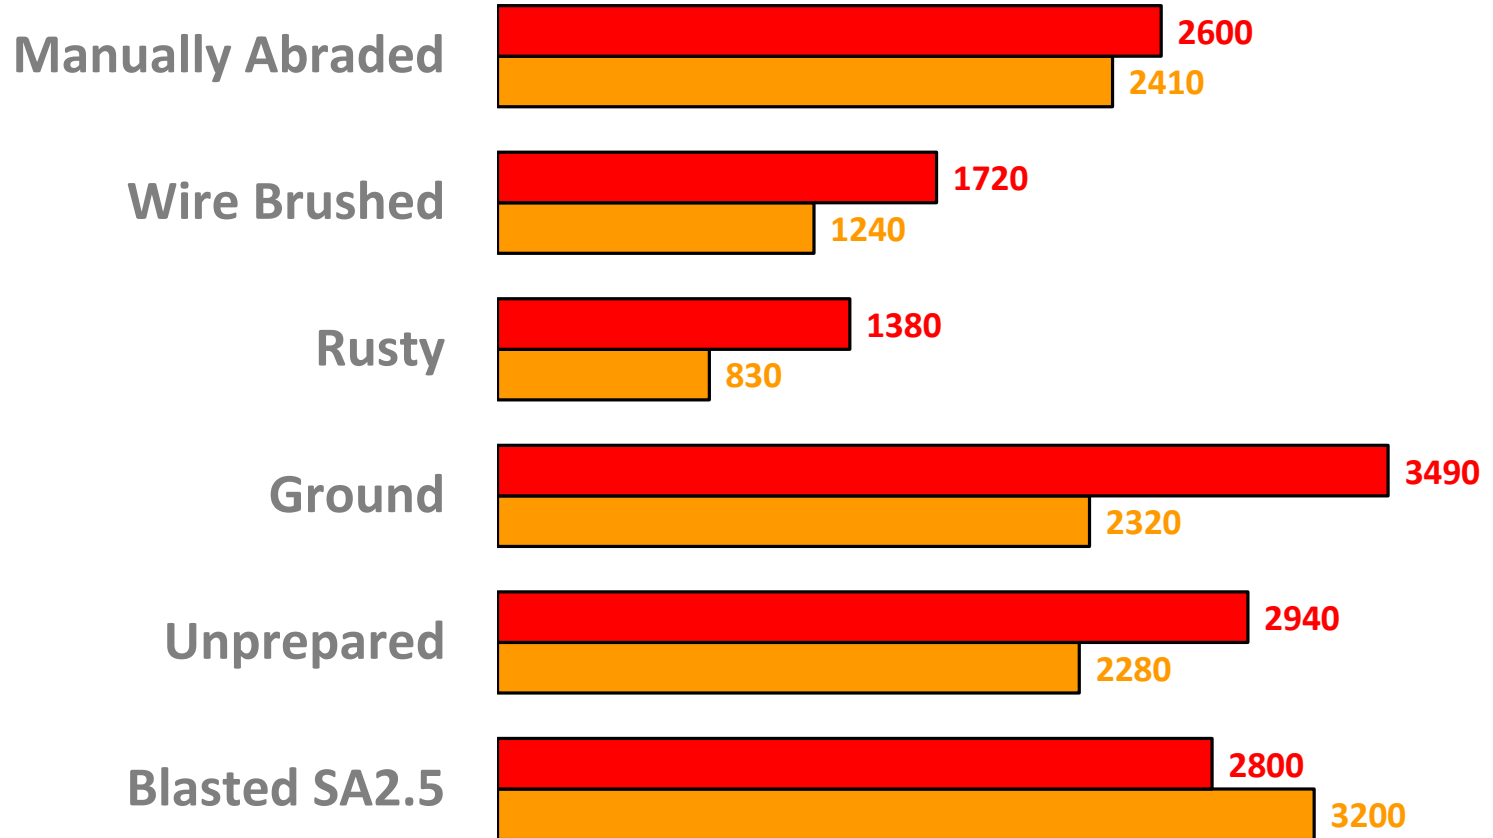
Adhesion

Belzona® 5851 performance

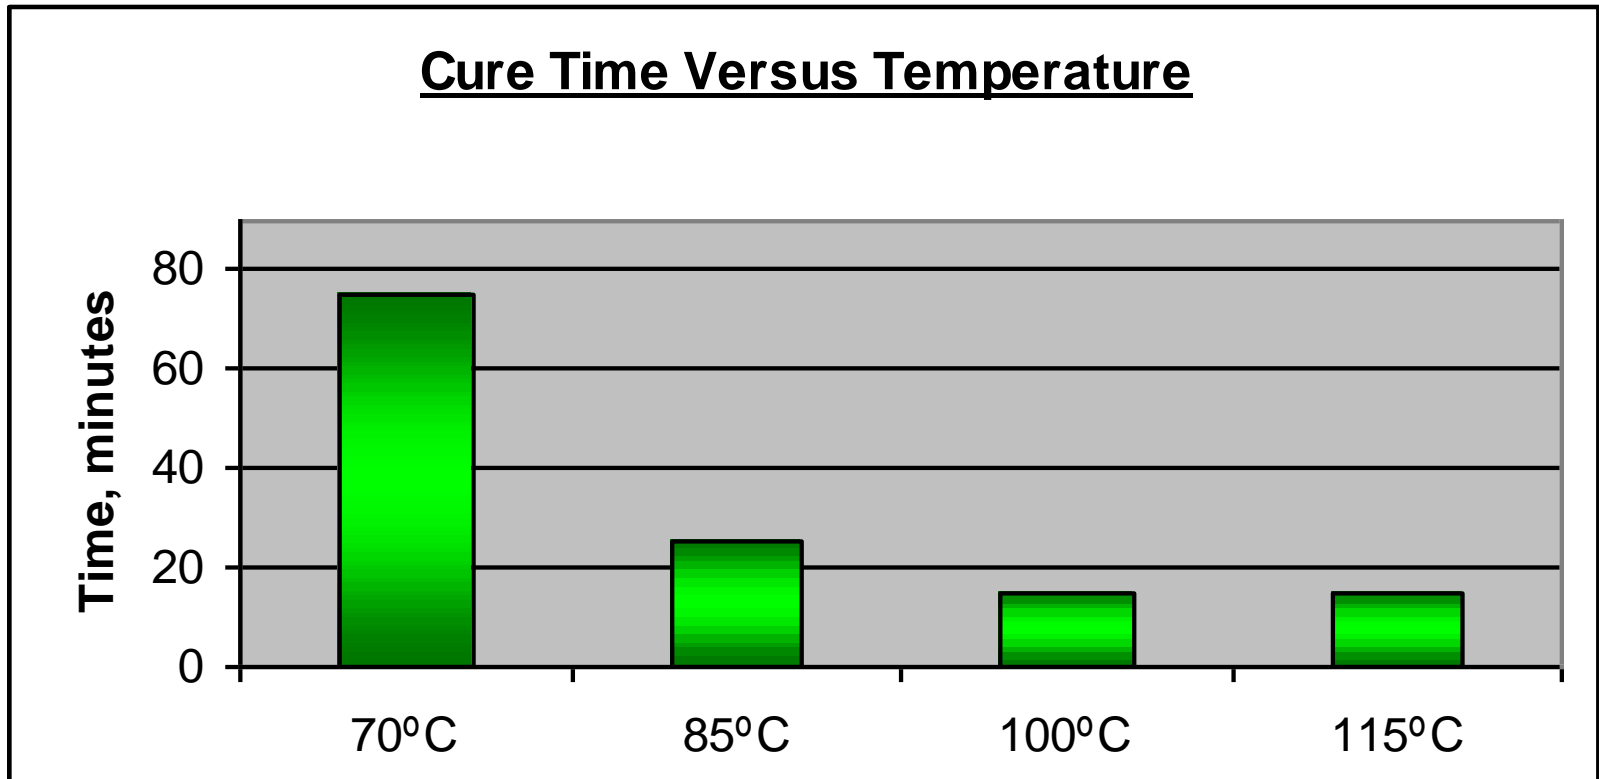
Cure Time

- Cure time decreases with increasing cure temperature
- Rapid 15 minute cure at 100°C/212°F

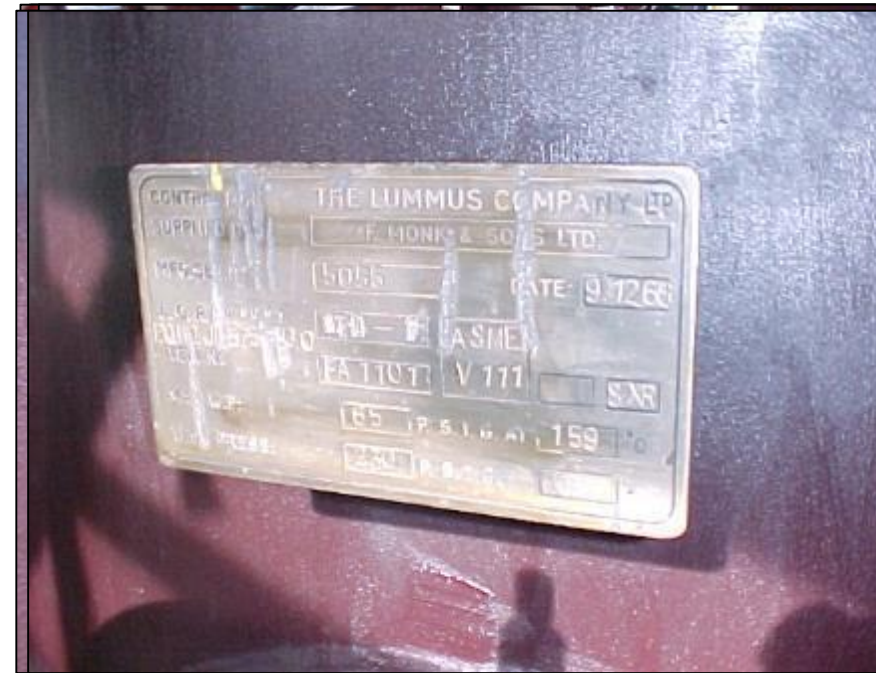
- Condensate vessel operating at 85°C suffering severe CUI
- Surface preparation – combination of hand wire brushing and power wire brushing to produce a tightly adherent rusted surface.
- Application carried out 16th March 2001
- Surface temperatures ranged between 110°C at the top of the vessel and 50°C lower down
- Two coats of product applied from top of the vessel down to approximately 2 thirds of the vessel height
- Coating application was halted when the vessel skin temperature dropped to 70°C
- Application completed in 4 hrs & the total cure time was under 3 hrs allowing vessel to be re-insulated.

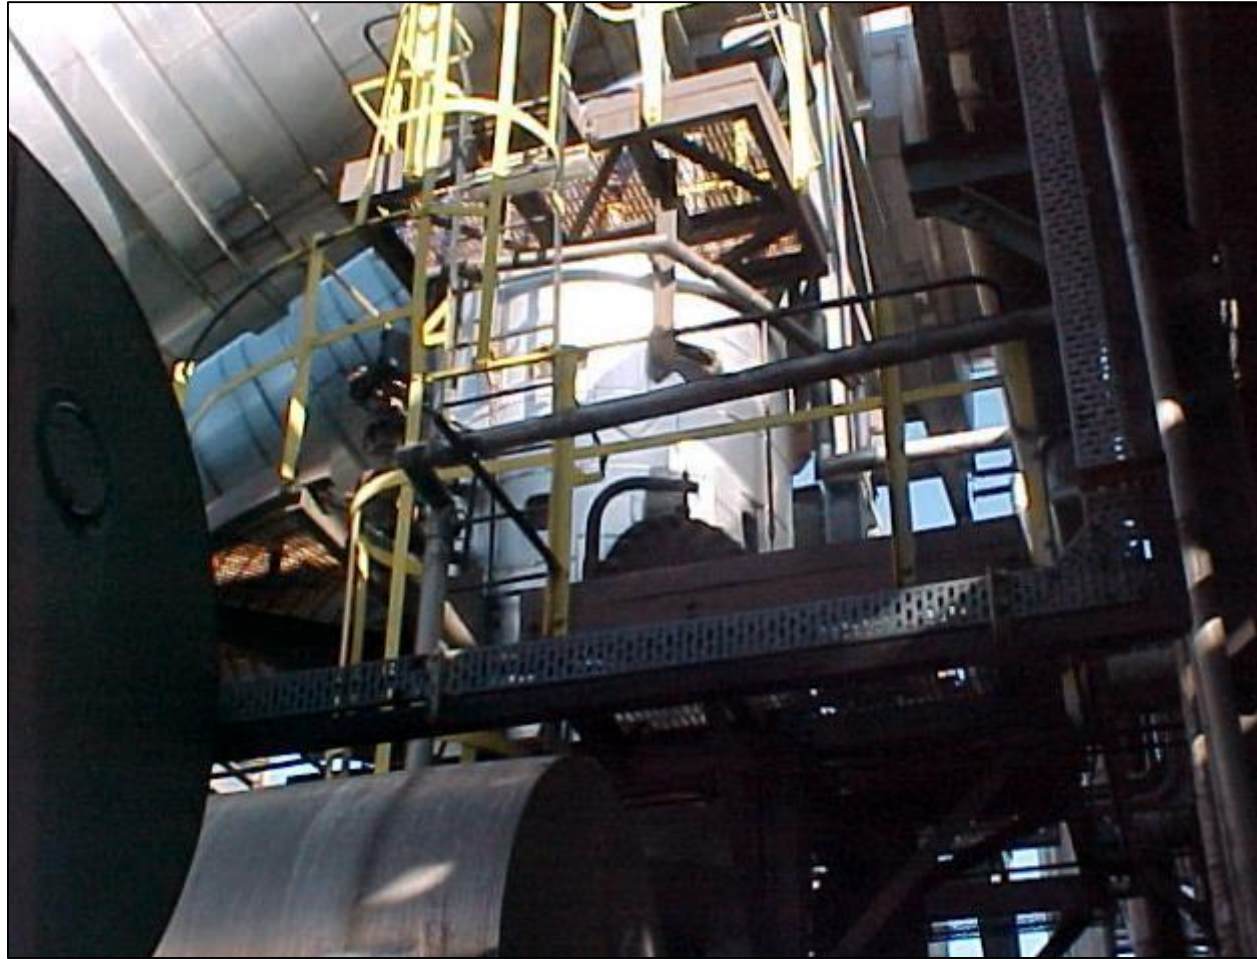
First in service inspection of Belzona 5851 on vessel 8D91 carried out 27th February 2002.

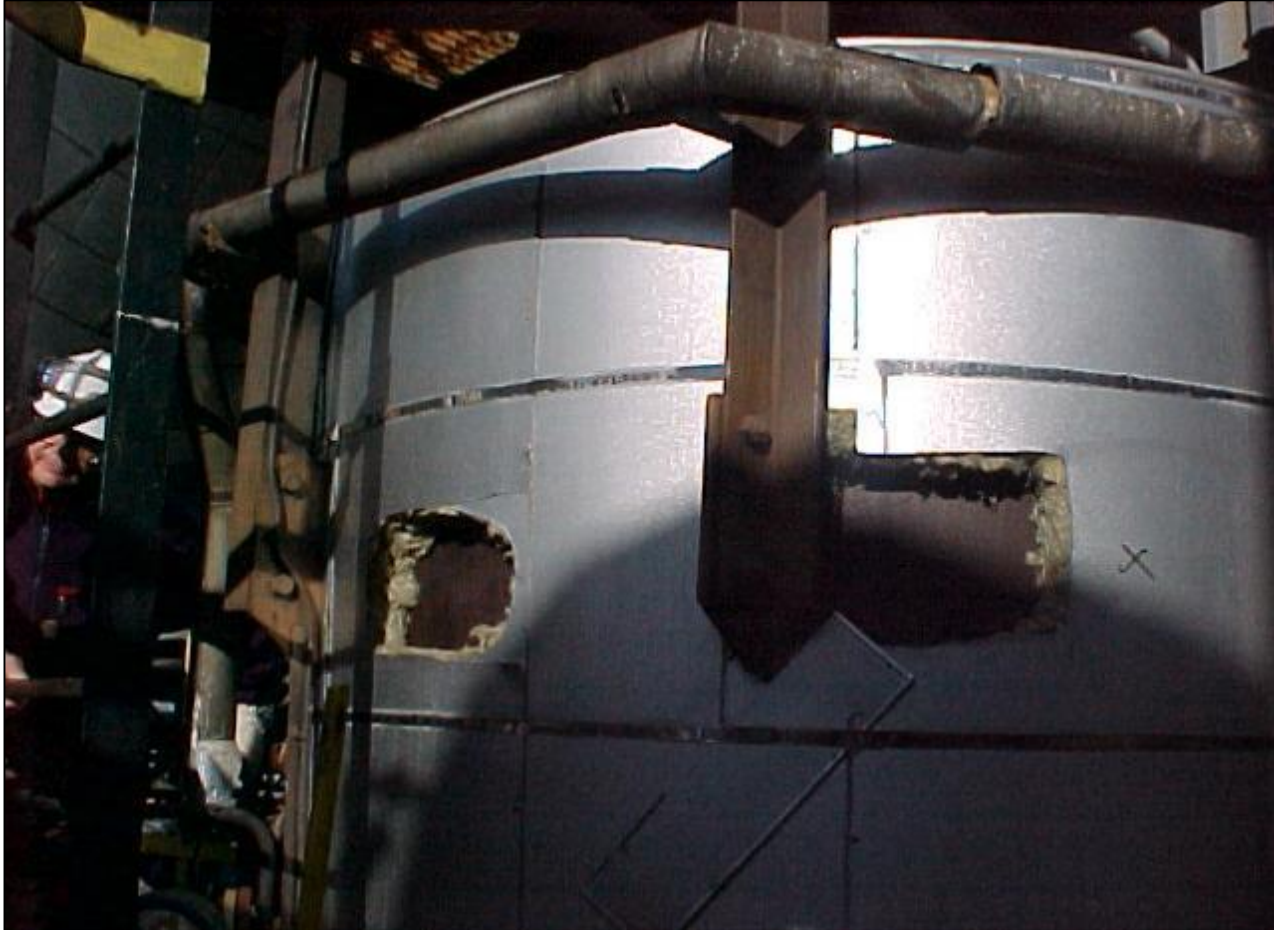
The condensate vessel had been lagged and had been in continual service for approx 12 months.

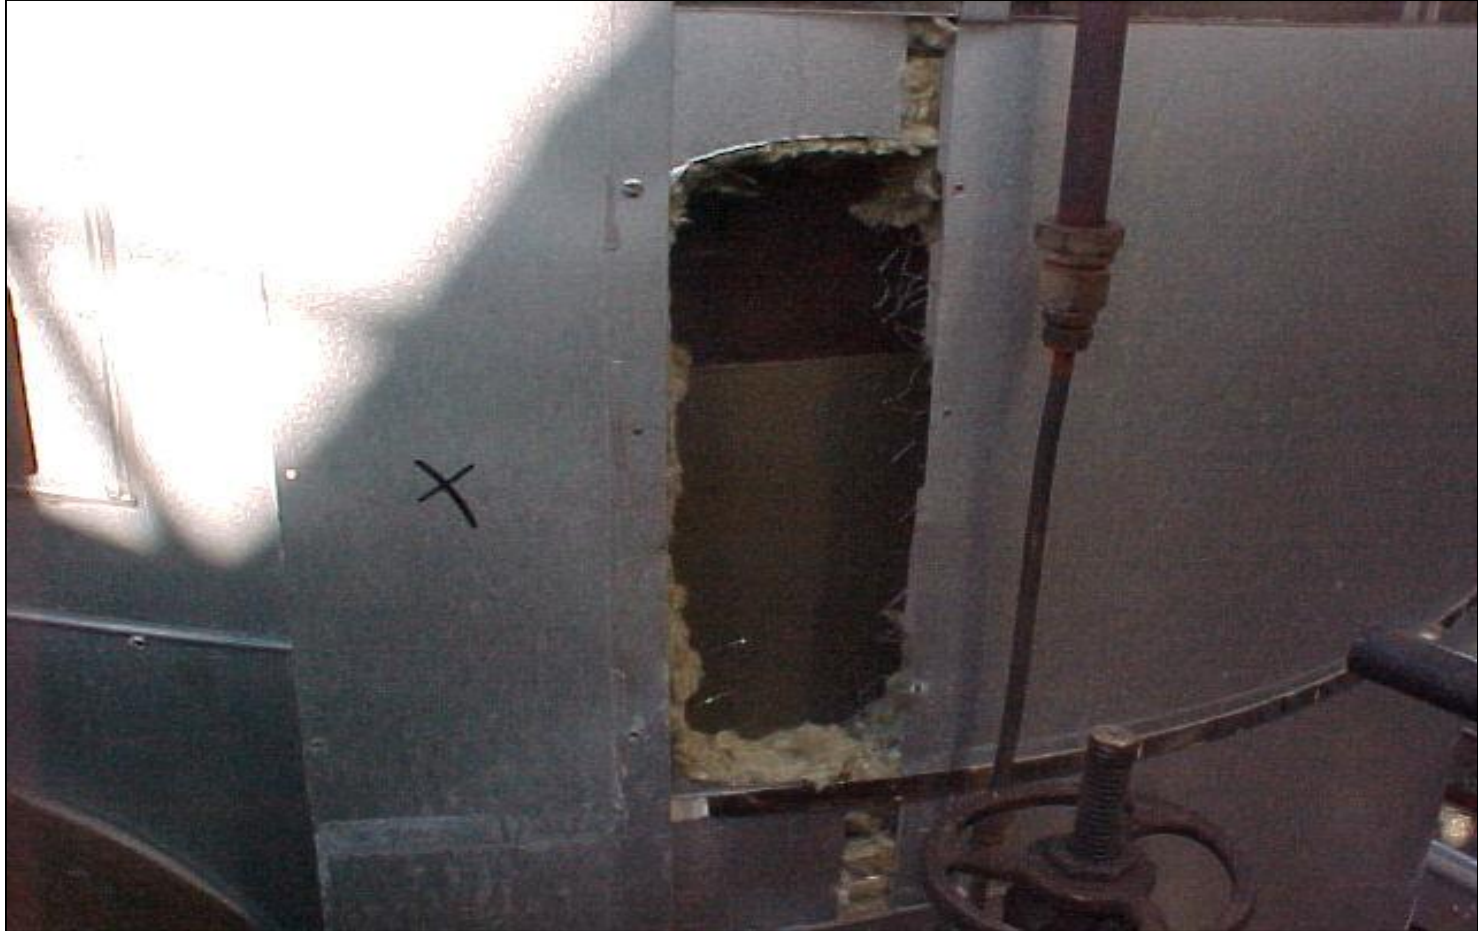
Sections of the lagging at various points had been cut away to facilitate this first 12 month inspection.

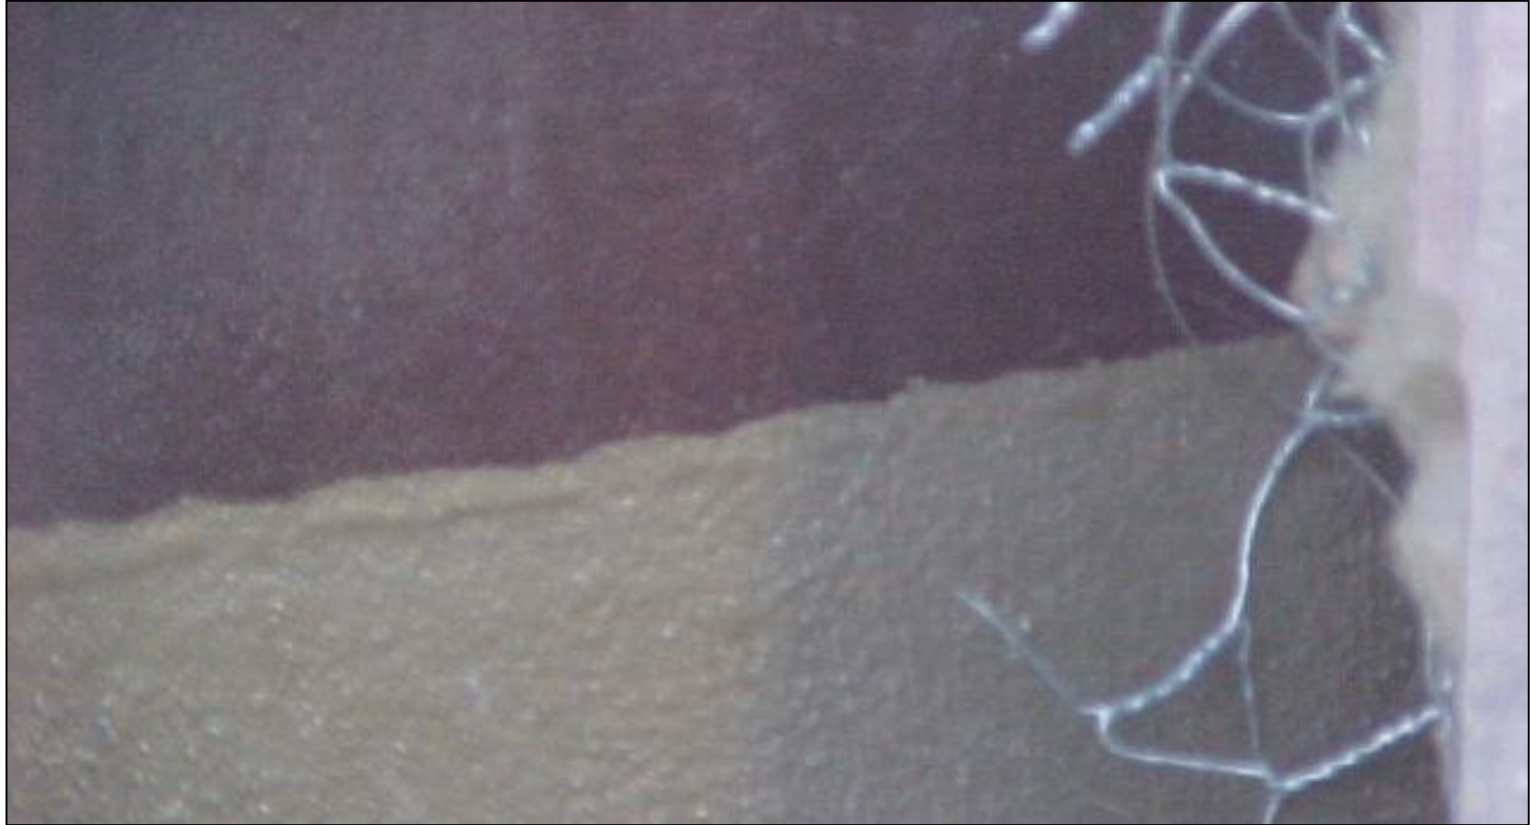
This area was performing extremely well with no defects in the coating.

Second in service inspection of Belzona 5851 on vessel 8D91 carried out late 2008.

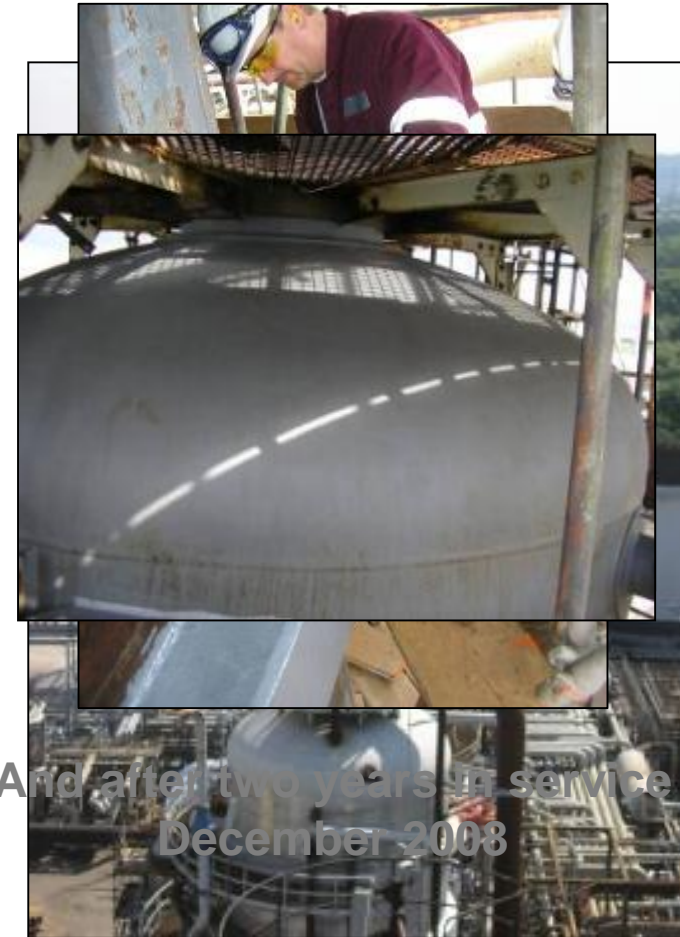
Shell Stanlow Refinery - UK

- Existing coating system failed resulting in severe CUI on distillation columns and fractionator towers operating at temperatures between 50-120°C Shutdown for repairs was going to be very costly
- Manual preparation of the steel substrate using scrapers and wire brushes followed by two coats of Belzona® 5851, March 2006
- The vessel wall temperatures were above 70°C but the insulation support rings were between 55°C and 65°C .
- Wire brush to remove all loose & flaking paint the apply Belzona® 5841 to the areas up to 75°C
- This successful application has led to significant use of these systems at the Stanlow refinery.

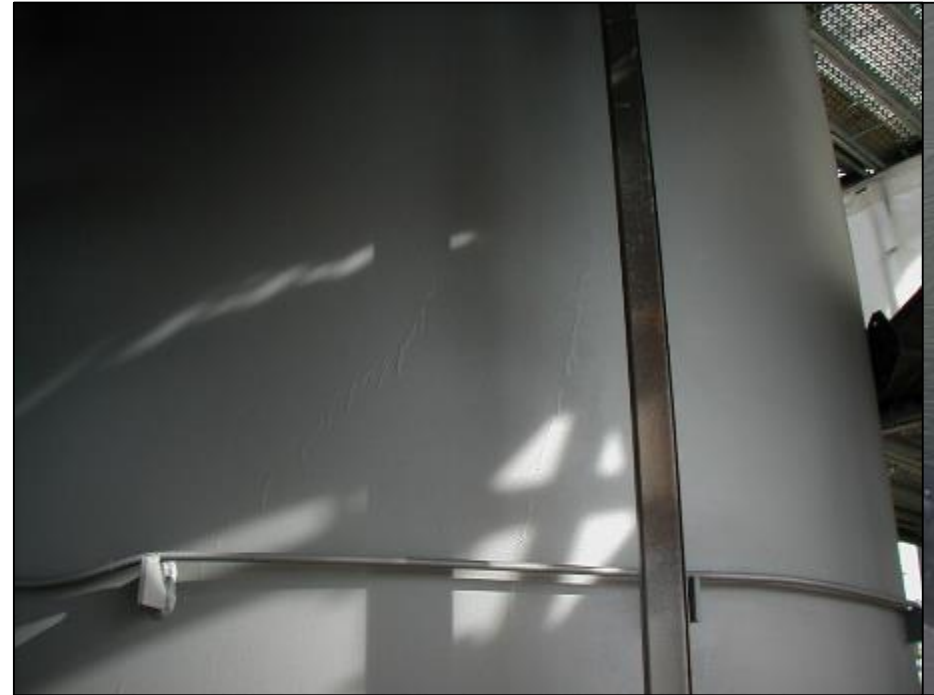
“Everyone is both surprised and impressed with the ease of application and the results

.....Completed the top half of a column in 4 days against 6 weeks using existing alternate material”.

- Two years into a six year programme of work, Shell were able to conduct direct comparison with TSA and with other organic coating technologies
- **Heat Activated System Advantages over TSA**
 - No need to blast clean substrate.
 - No need to tent in area to retain blast media.
 - Not creating confined spaces to manage emergency plans for.
 - Application of two coats onto hot surfaces easy.
 - Avoiding equipment “hot work”.
 - Less risk of misses.
 - Less risk of coating failure due to thin film or missed areas.
 - Significant savings in time and money.

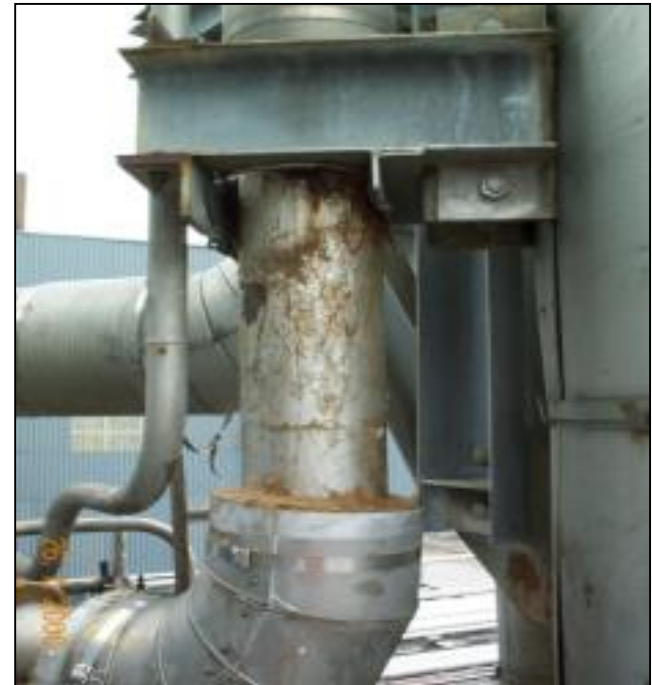
Heat Activated Composite Repair Solution – Shell Refinery New Zealand Year 2003

**Ongoing Inspection shows no deterioration of the coating
after 12 years in Service.**

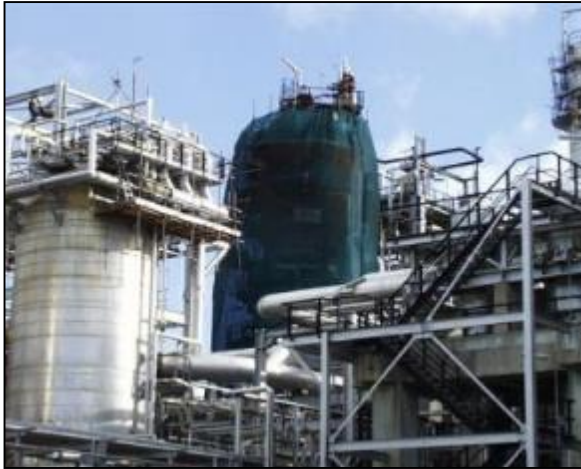
De-Asphalting Column
in service with operating
of 120 C

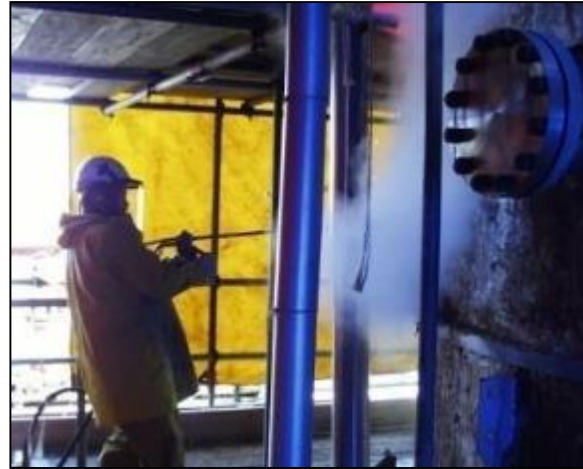
Surface Preparation Carried
out Using High Pressure
Water Jetting

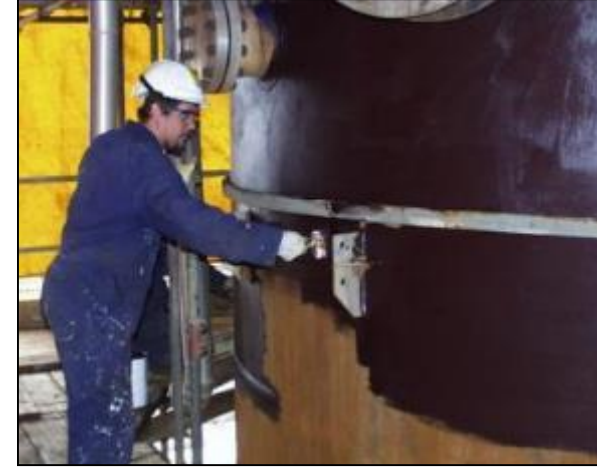
Application of Heat
Activated Coating System
using rollers and brushes

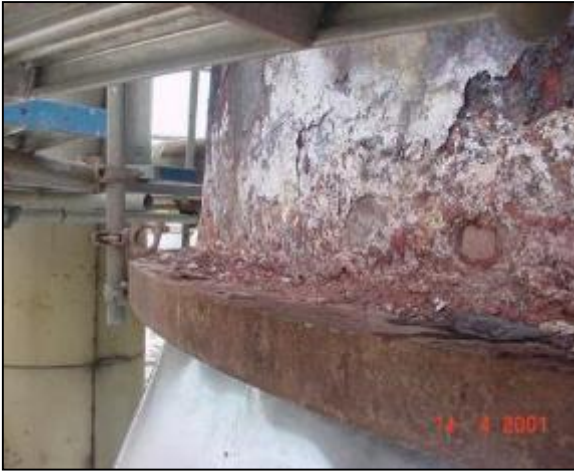
Fractionator Tower T102
in service operating
at 120C

**Ongoing Inspection shows no deterioration of the coating
after 14 years in Service.**

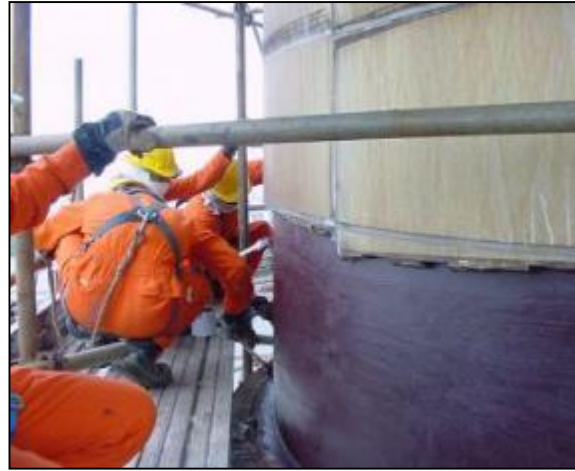
Surface preparation carried
out using scrapers to remove
loose rust to ST2 finish

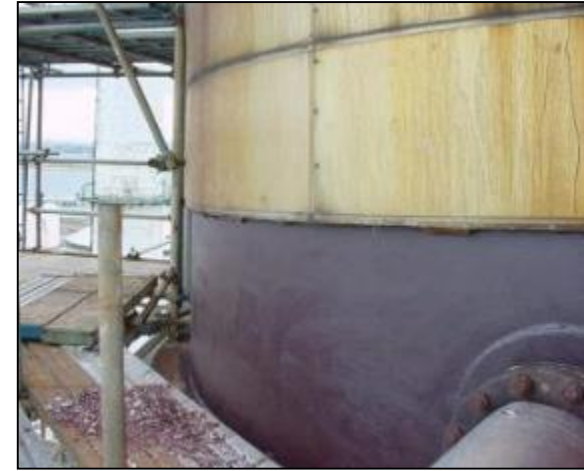
Application of Heat
Activated Coating System
using rollers and brushes

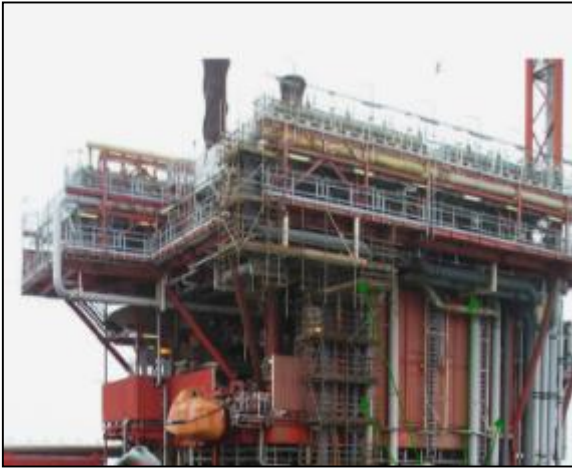
Gas - Condensate Pipework
operating at temperatures
up to 115C

**Ongoing Inspection shows no deterioration of the repairs and
after 10 years in Service.**

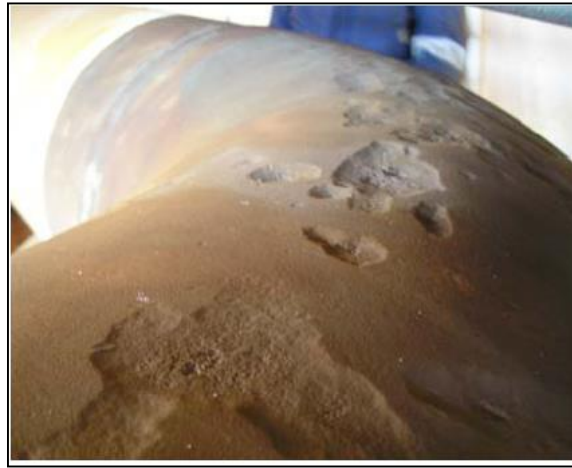
Surface preparation carried
out using high pressure
water jetting

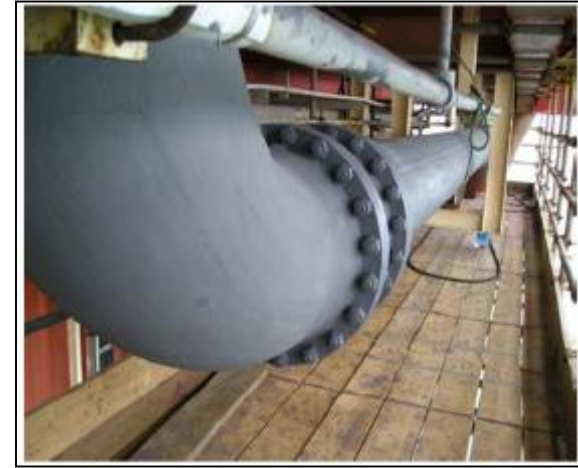
Heat Activated Composite
wrapping and coating carried
out on-line
