## Tube Failure of Vertical Heat Exchanger

Ali Sami Al-Hassan  
Sr. Inspection Engineer  
Sipchem

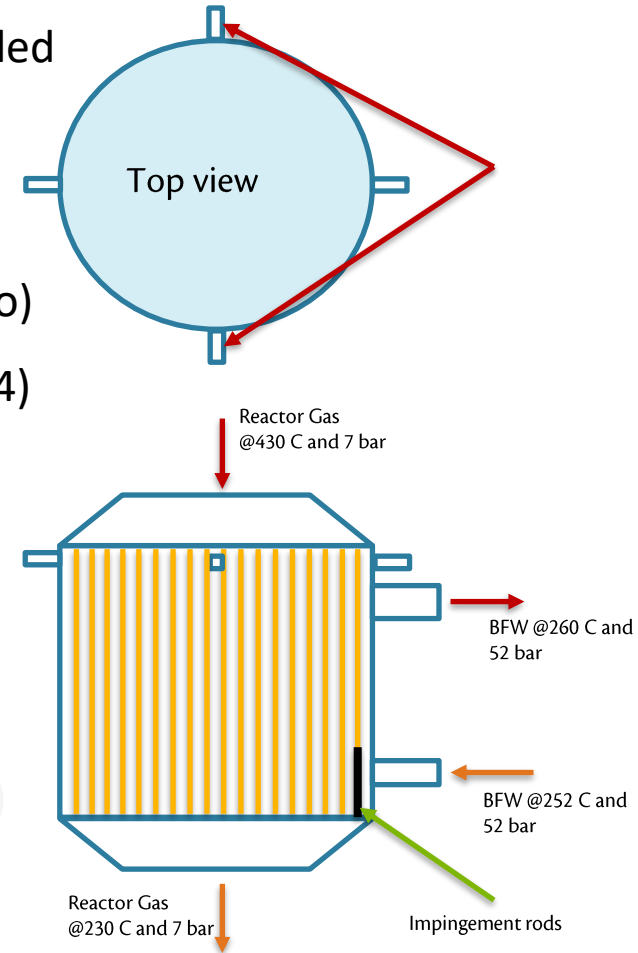
## Modification on New Exchangers (2014)

- Upgrade the MOC (tubes with higher Chromium “Cr”) Old: SA209-T1 (0.5% Mo), New SA213 T11 (1.25% Cr, 0.5% Mo)
- Adding vent points (nozzles) on the top (increased from 2 to 4)
- Add rods impingement instead of plate impingement
- Reduce the number of tube 4008 to 3584 (remove the tubes near the BFW Inlet nozzle).
- Maintain the BFW chemistry within the specifications.
- BFW outlet nozzle was repositioned to be closer to top tubesheet

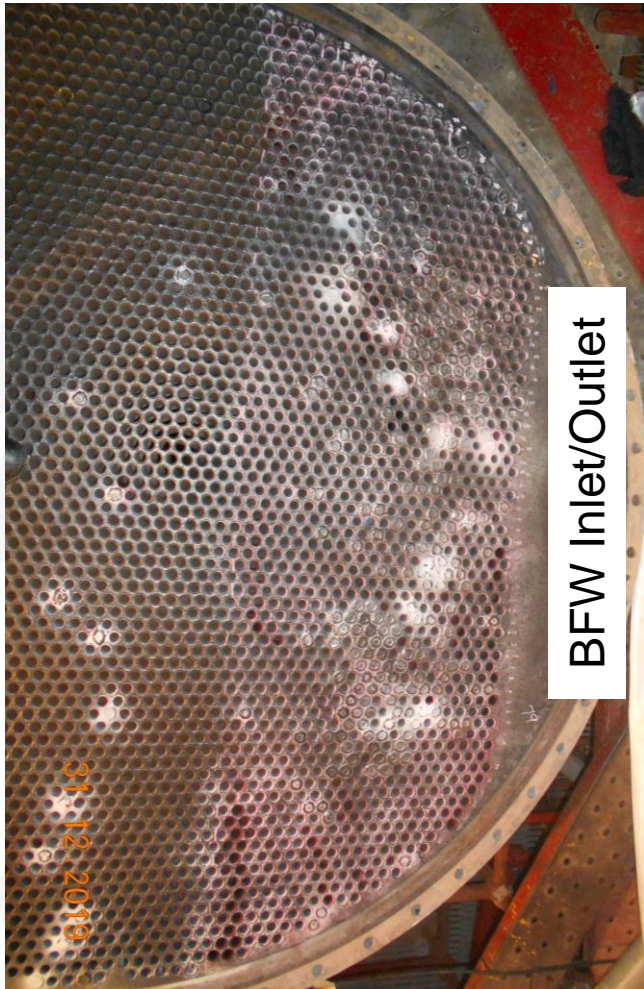
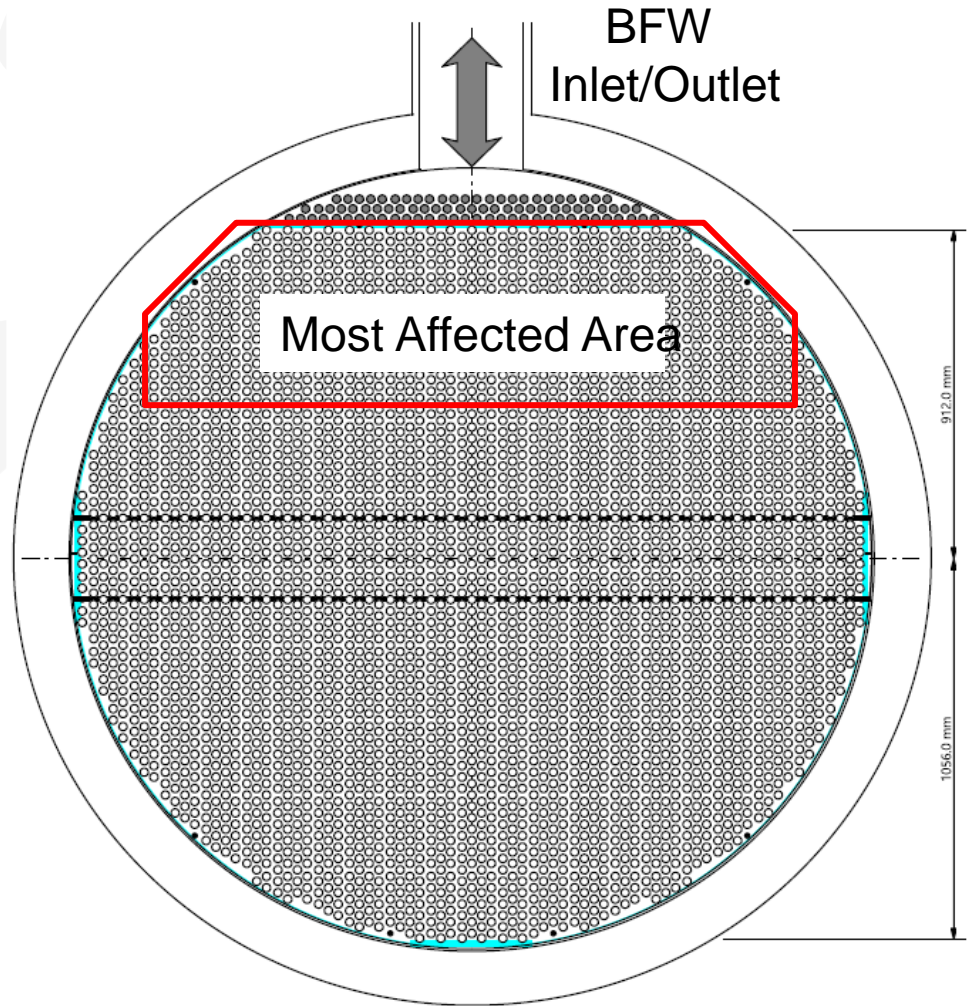
# Tube Failure Investigation (2019)

- For the purpose of analysis, 2 tubes were pulled and sent for failure analysis
- **Tubes Condition:**
  - Tubes were sheared during pulling indicating a weak area and found the tube near the sheared location to have external damage (deep grooves).
  - The damage is located around 100mm from the top tube sheet.
  - No apparent damage observed on the plane of BFW inlet

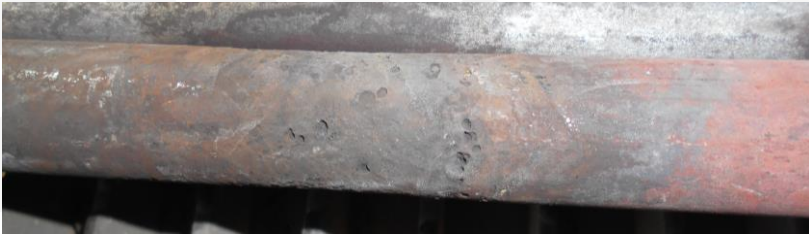
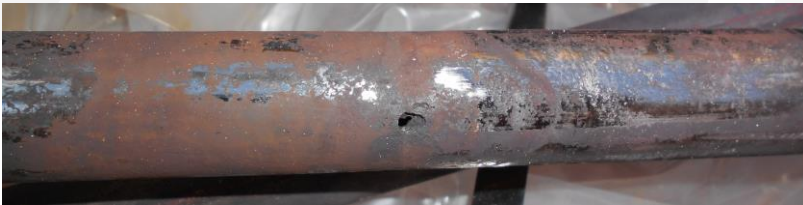
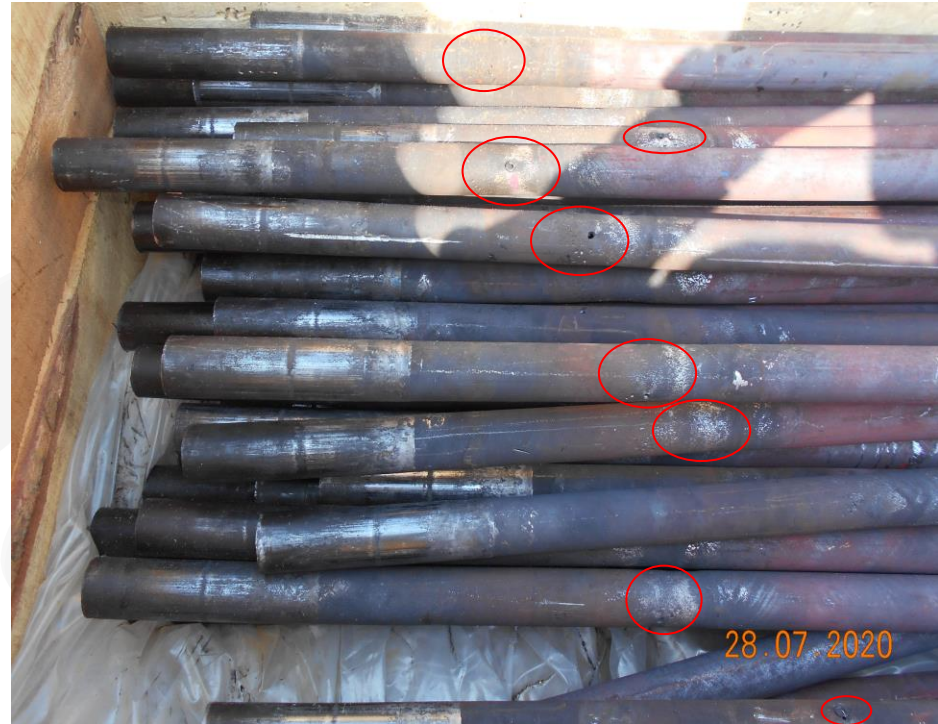
## Tube Failure Investigation (2020)

- The manifestation of the steam blanket is an inherent design issue that will persist as long as the exchanger orientation is vertical
- The location of the BFW outlet nozzle makes it impossible for the BFW level to be full up to the top tube sheet
- All corrosion (pitting) occurred on the tubes external surface at the interface between the steam and the BFW.
- The damage is localized and more severe at BFW outlet

- Strict control of Boiler Feed Water (BFW) Chemistry, it shall be maintained always within the specifications.
- Explore the possibility to install ceramic sleeves at the top tubesheet reduce the heat below the tubesheet and minimize the steam blanket
- Explore the possibility to replace the exchanger with horizontal design to eliminate the presence of the steam blanket
