UNEXPECTED SILENT KILLER IN HIGH-GRADE MATERIAL

RAYAN SALWATI
PETROMEMYA , SABIC
SAUDI ARABIA

INTRODUCTION

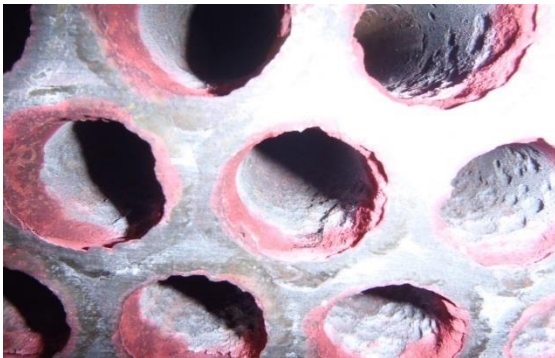
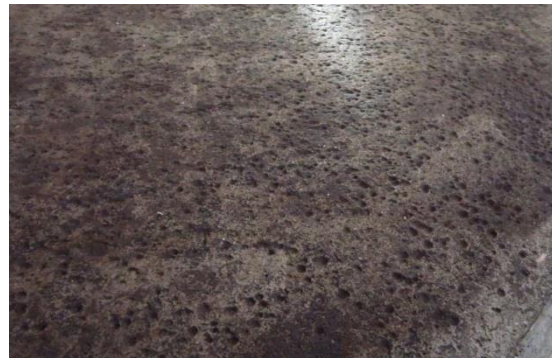
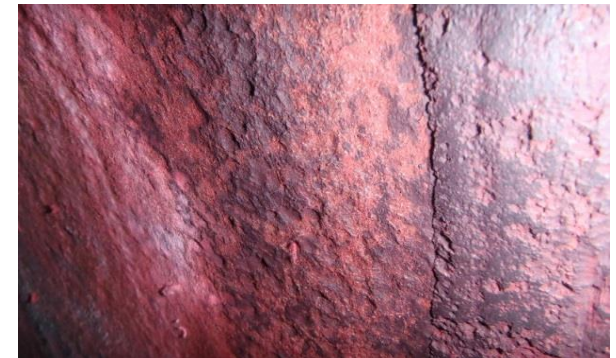
- During scheduled turnaround of VCM plant in the month of Oct-Nov-2014, Heads Column Condenser was inspected as a part of preventive maintenance. it was supposed to be a normal clearing job. However, after opening the exchanger many observations and damages were found in separate locations. Severe pitting on tube ID and localized corrosion were found on the hot side i.e. tube inlet side. The tube-to-tube sheet area had pitting around 2mm deep. Pitting and loss of thickness beyond the acceptable limit were found in 350 tubes. Many tube-to-tube sheet joints were found severely damaged.

- On the other hand, there was no any significant damage either in tube or in tube sheet at the tube outlet.
- The tube material of this exchanger is duplex stainless steel Alloy-2205, the tube sheet is carbon steel clad with Inconel 625. The target was to extend the life to 10 years but it failed after 18 months only.

- The original material was carbon steel and it worked up to 10 years, then it was upgraded to SS after 10 years and it worked up to 2 years only. After the SS failure it was upgraded to DSS.

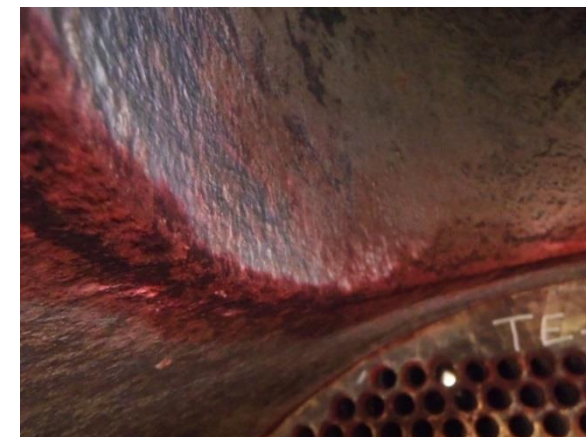
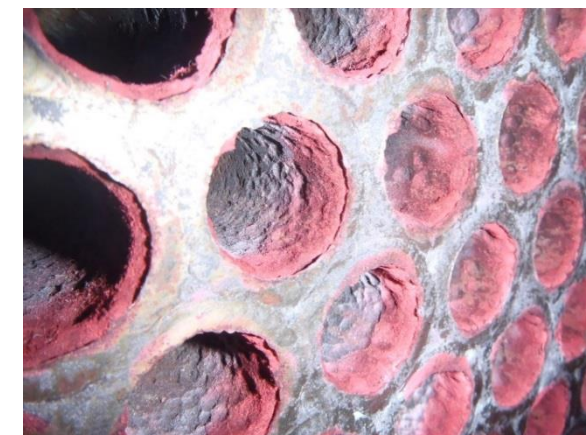
1. Corrosion pitting (About 0.5 mm to 2.5 mm deep) at Internal surface.
2. Pinholes & corrosion pitting was observed 36 tubes to tube sheet seal weld.
3. Deep pitting were observed over 60mm length inside the tube surface for entire tubes.
4. Thinning observed on all tube-to-tube sheet seal welds at both north & south

Many tubes were found leaking which could not be quantified during shell side hydro test.

Out of 1301-Nos. 70-Nos. with wall loss from 40 % to 100 %

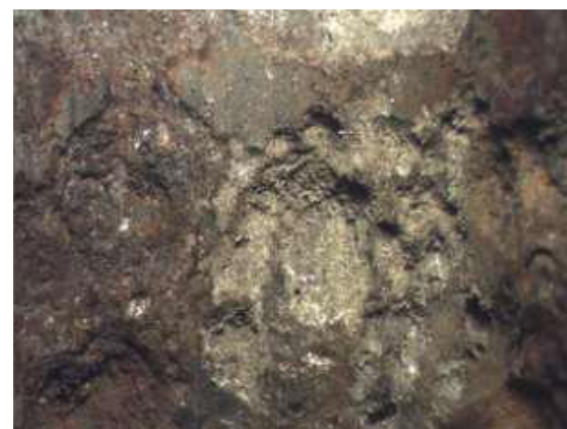
Inner surface low magnification views. Pitting corrosion is noticed which is surrounded by uneven but adherent scale on the surface.

Inner surface low magnification views

• Stagnant.

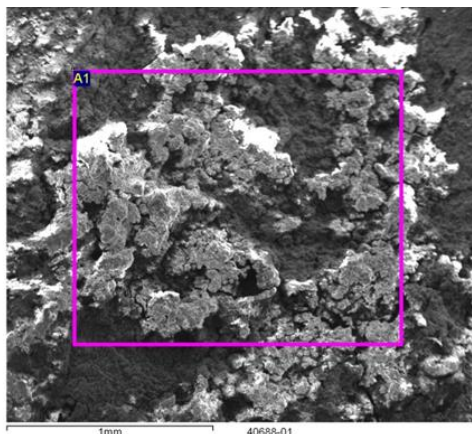
Results reveal the material to be a Standard Duplex Stainless Steel.

• Material conformed

• Low pH feed.

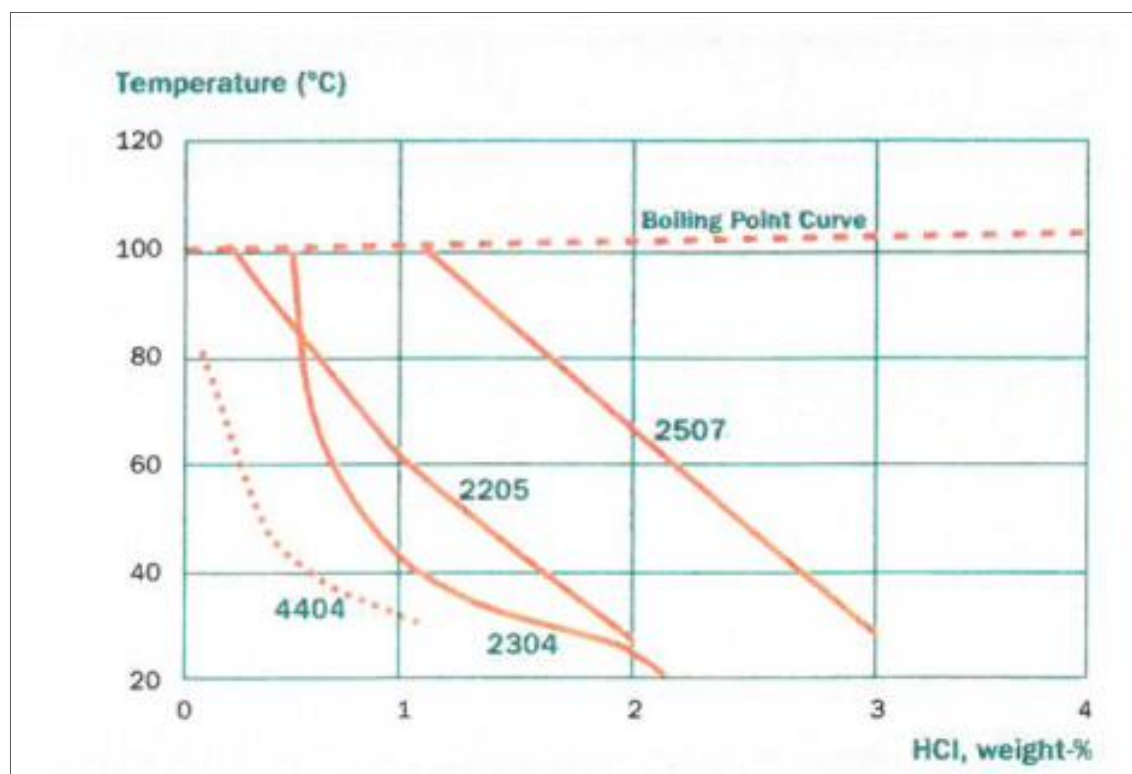
Severe pitting corrosion of alloy 2205 at about 81°C indicates that concentration of hydrochloric acid was about 1% on the tube surfaces at inlet areas, as per the below iso corrosion curves 0.1mm/year, in Hydrochloric acid.
